LEE COUNTY PAVEMENT CONDITION REPORT (PASER)

BRIAN TJERNLUND P.E.
ASSISTANT COUNTY ENGINEER
LEE COUNTY HIGHWAY DEPARTMENT
4/10/2023

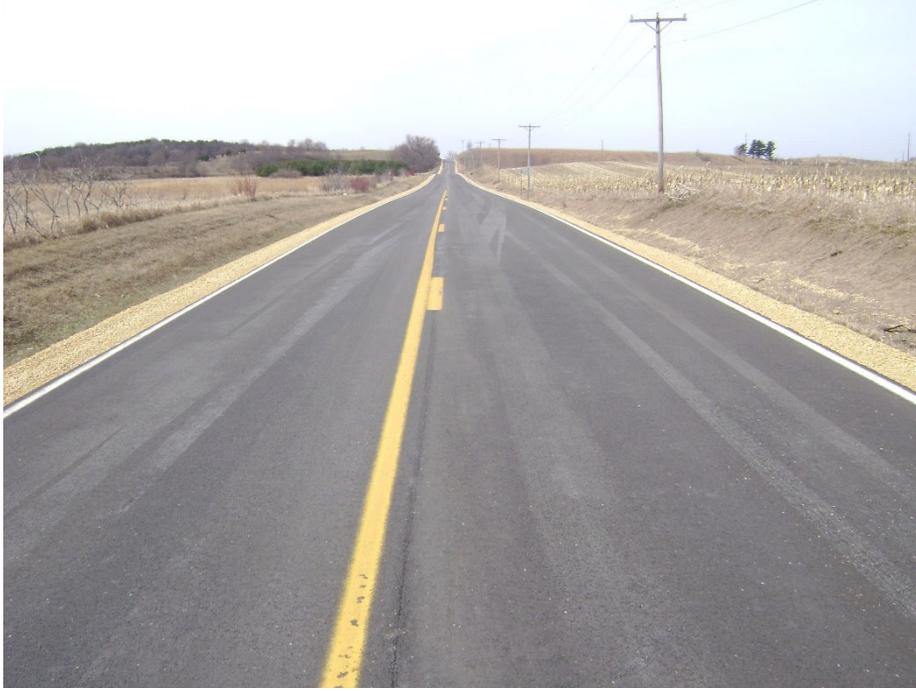
Asphalt Rating 9 – Excellent, recently placed HMA overlay

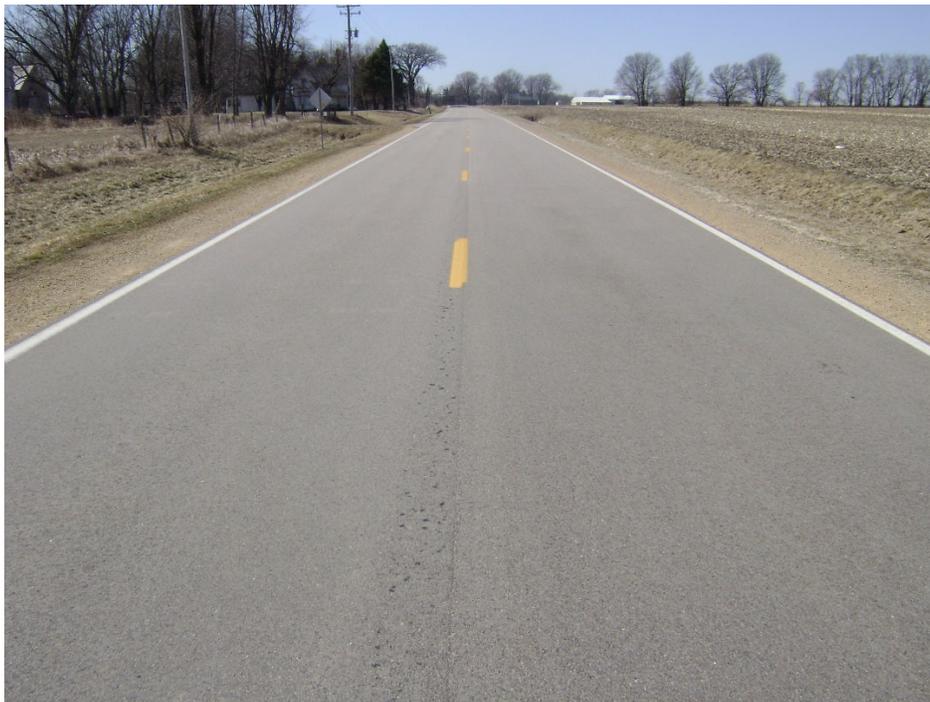
Asphalt Rating 8 – Very good, no issues of concern

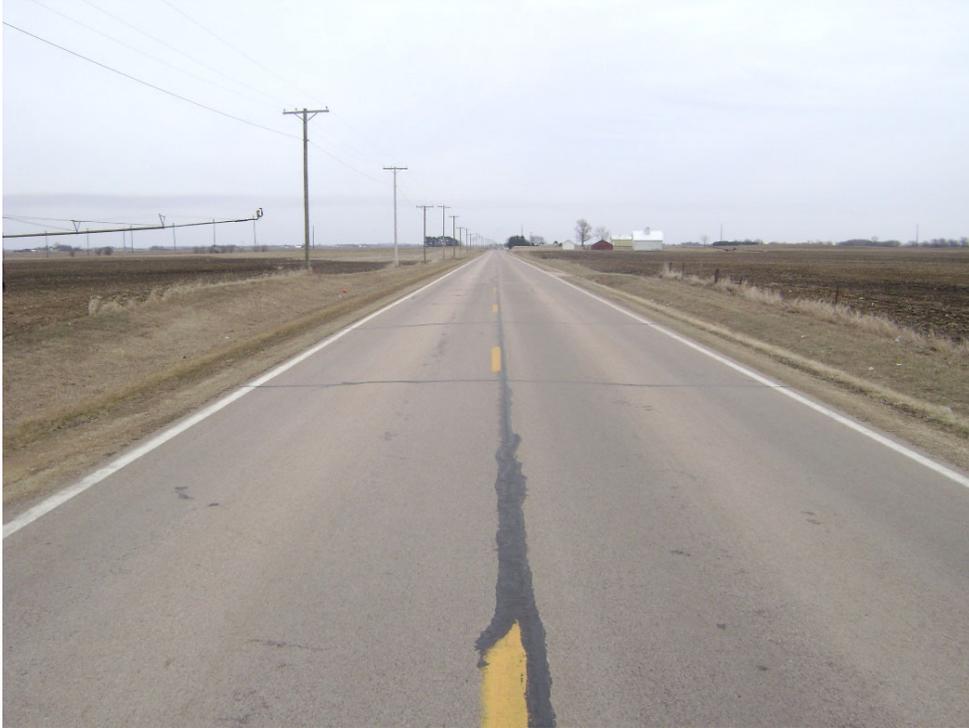
Asphalt Rating 7 – Good, transverse cracks more than 10 feet apart with crack filler

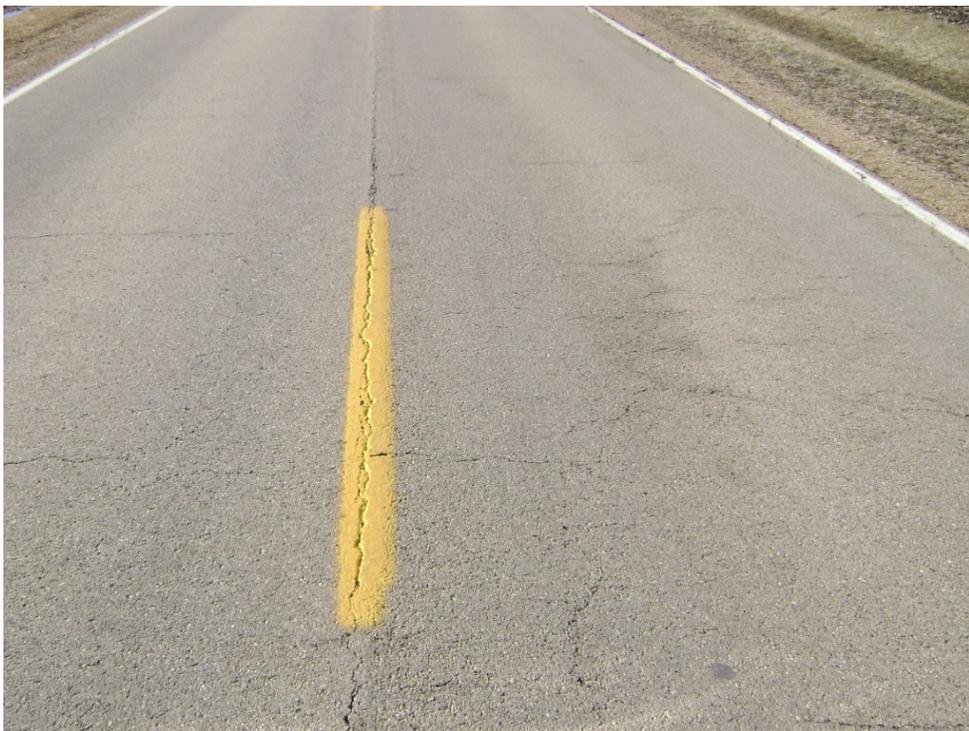
Asphalt Rating 6 – Good, transverse cracks less than 10 feet apart

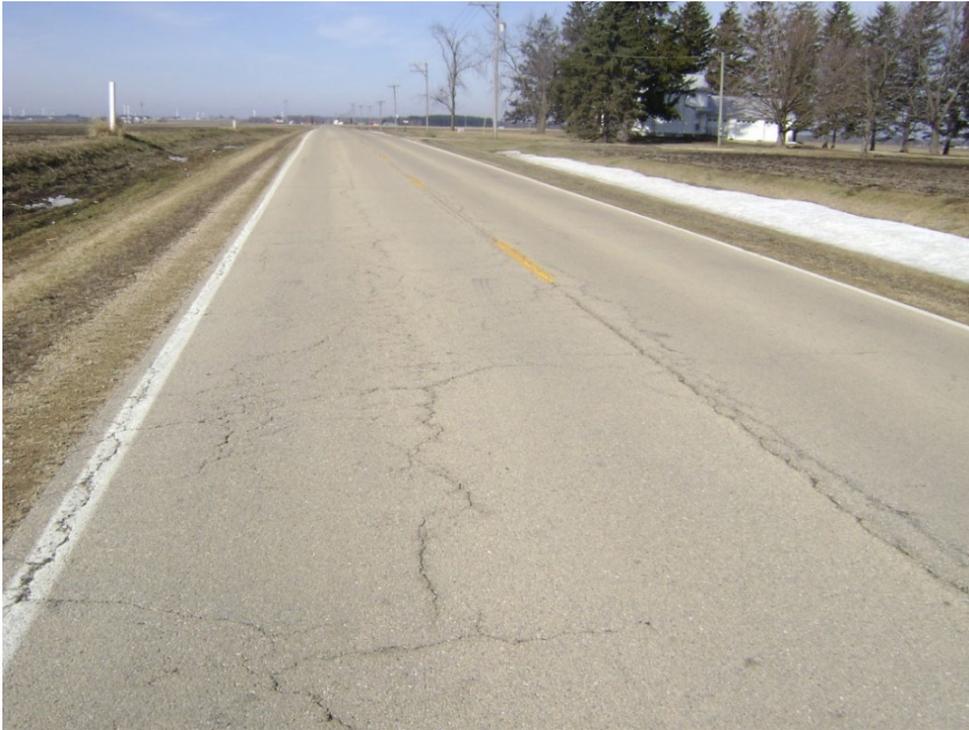
Asphalt Rating 5 – Fair, block cracking up to 50% of area

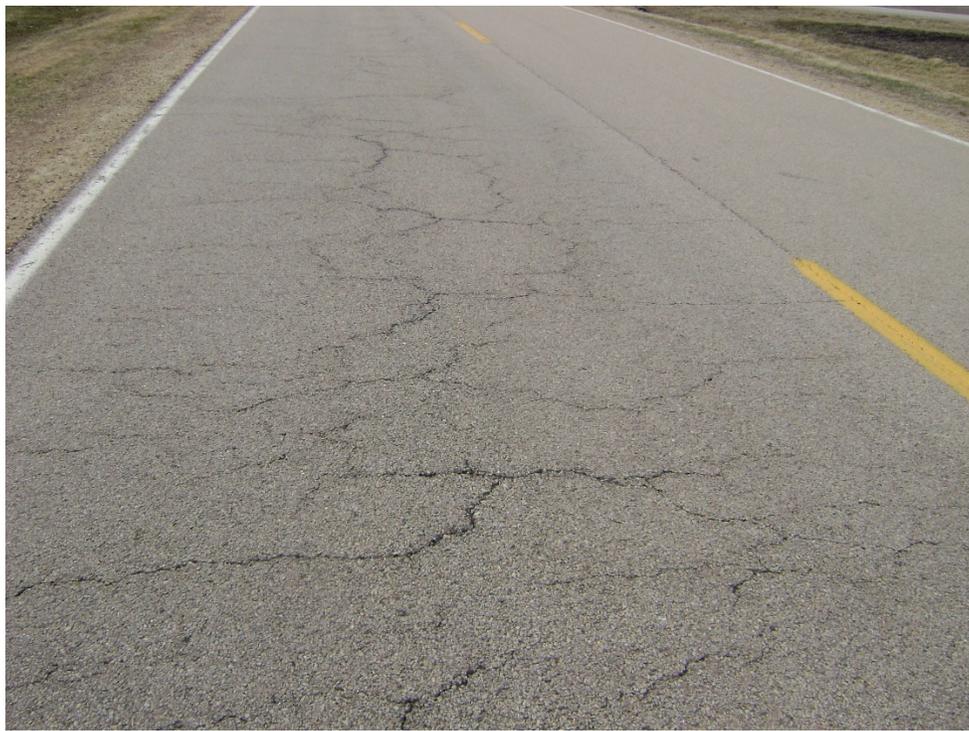
Asphalt Rating 4 – Fair, irregular shaped block cracking over 50% of pavement

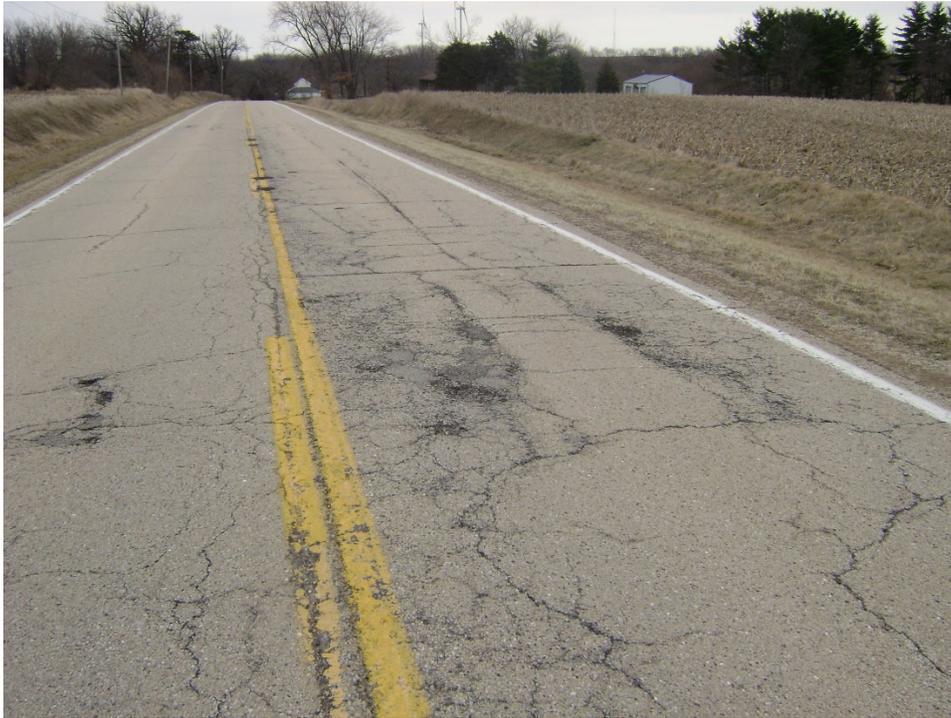
Asphalt Rating 3 – Poor, alligator cracking and potholes beginning

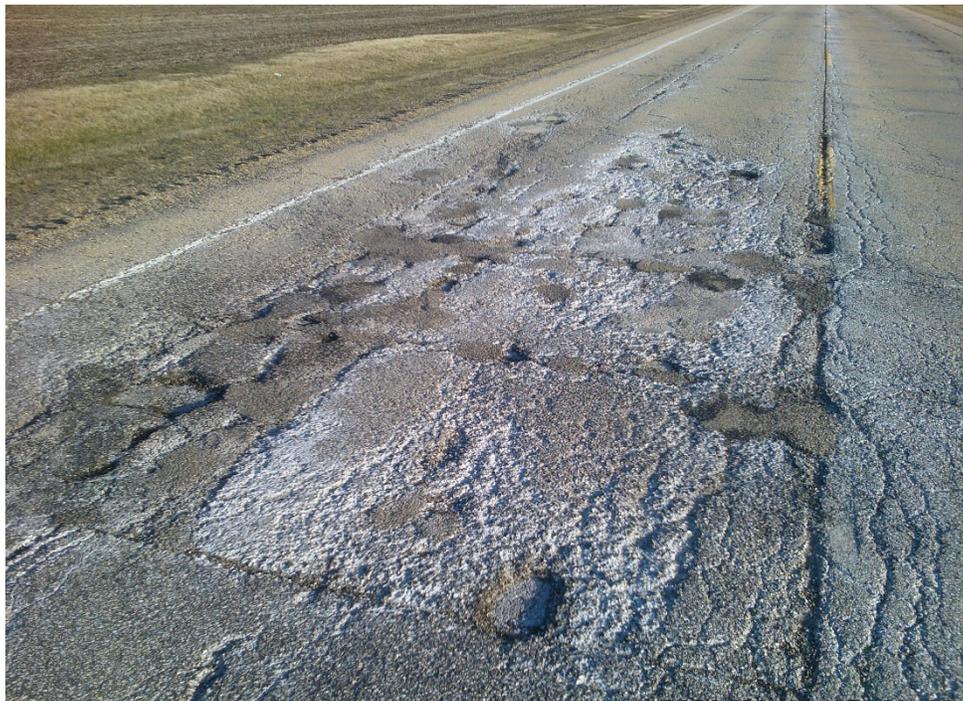
Asphalt Rating 2 – Very Poor, potholes and patching in poor condition

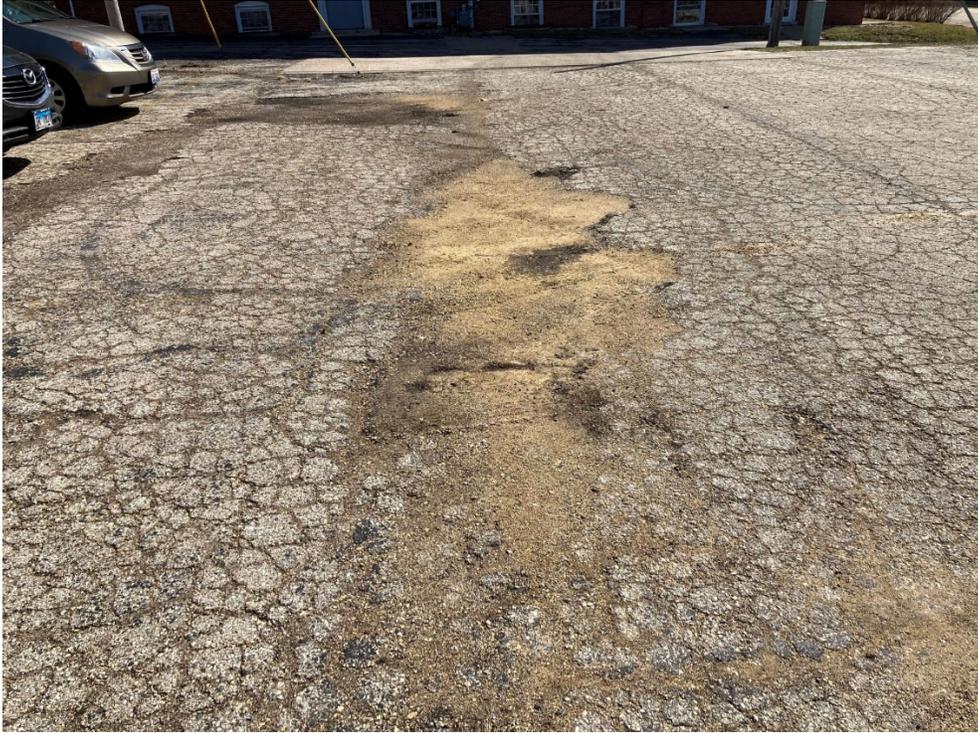
Asphalt Rating 1 – Failed, surface has lost its structural integrity

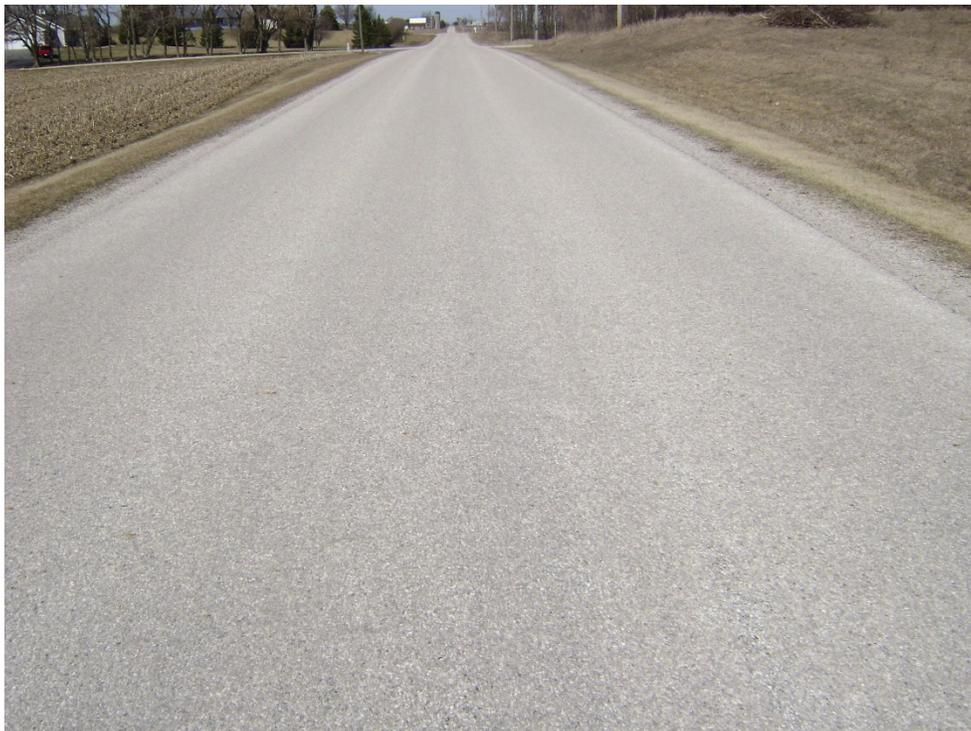
Sealcoat Rating 5 – Excellent – no issues/like new

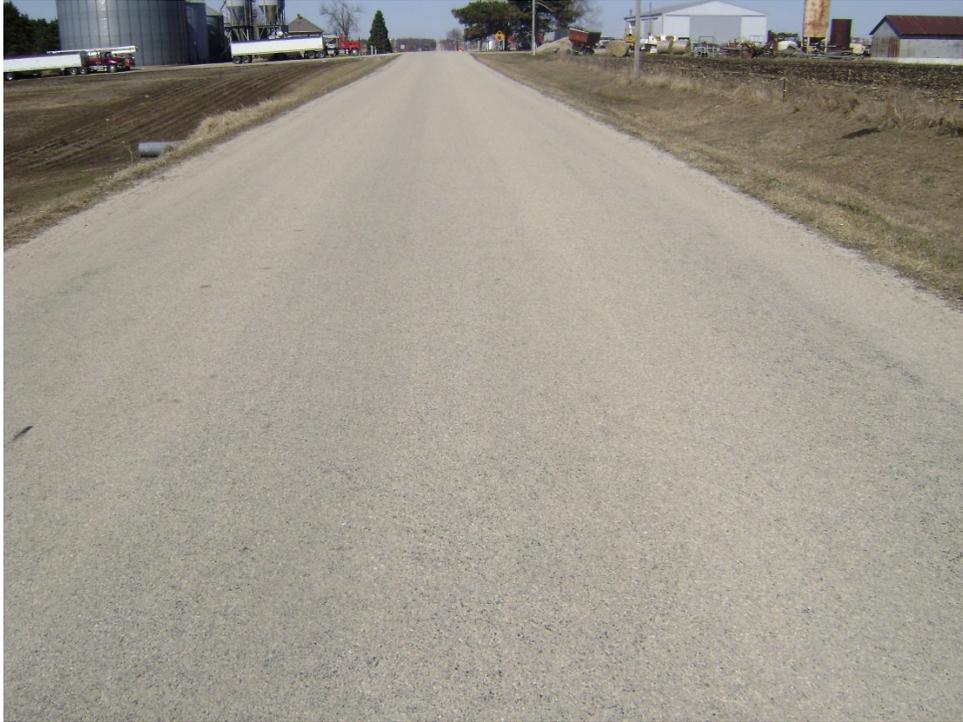
Sealcoat Rating 4 – Good – some aggregate loss

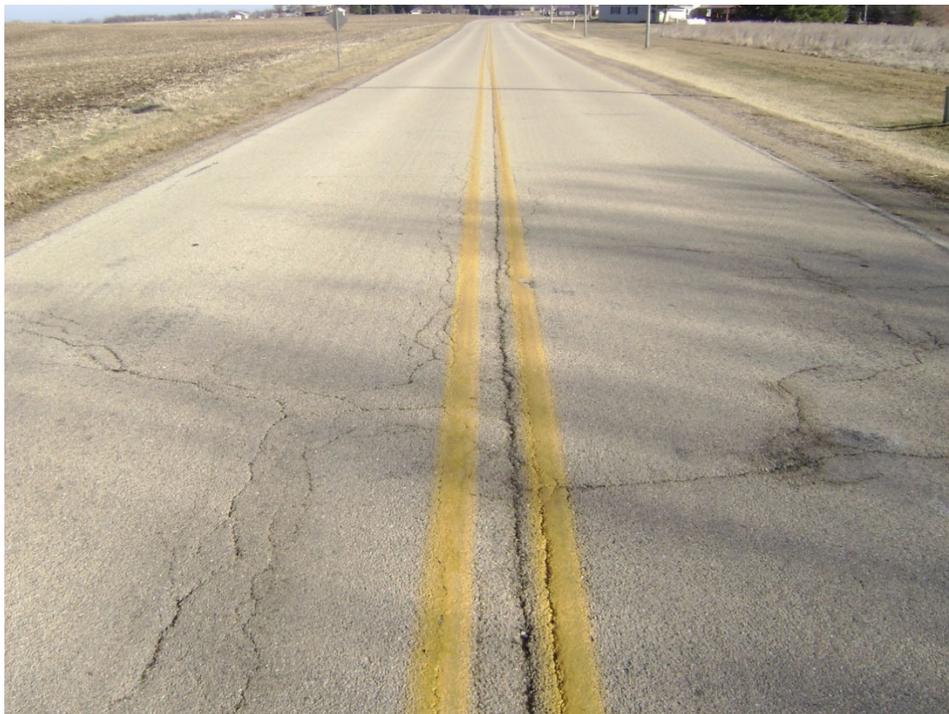
Sealcoat Rating 3 – Fair – cracking throughout sealcoat

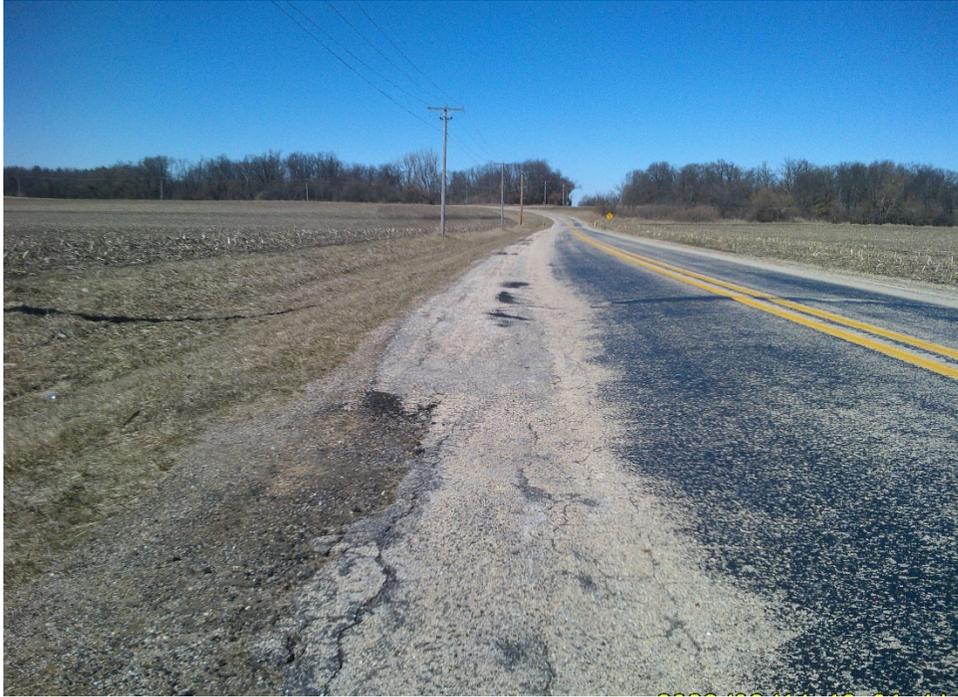
Sealcoat Rating 2 – Poor – Flushing, edge cracking and severe rutting

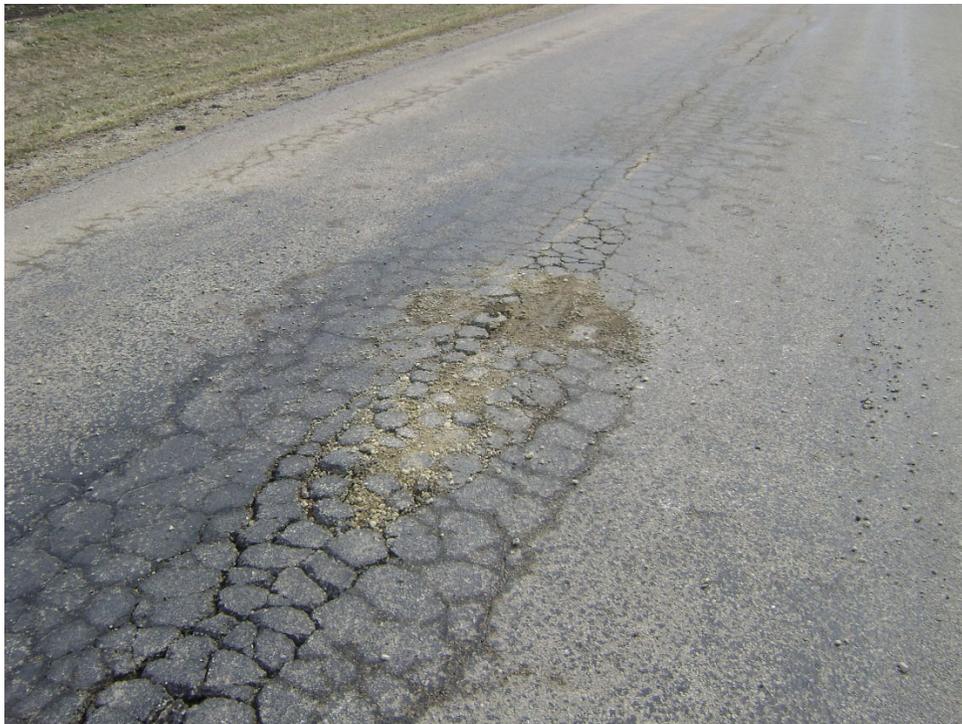
Sealcoat Rating 1 – Failed – loss of surface and mud is pumping into stone layer
