SETH
STRUCTURAL
ENGINEERING

Structural Review of the Existing Building at in Pennsylvania

Structural Review with Photographs

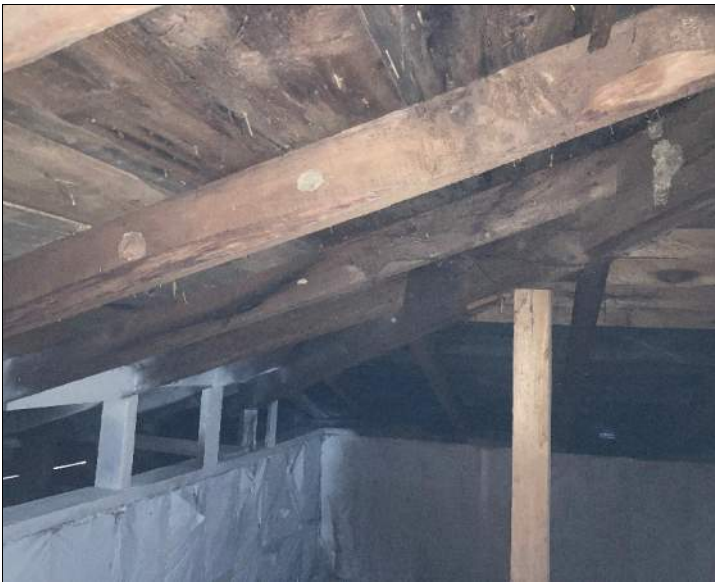
Addition: Roof Framing

- The 3"x5" roof joists are spaced at 27" are undersized for the loading, span, and spacing.
- The 2"x9 ¼" hip beam is undersized for span and loading.
 - Posts have been added near the center of the hip beam span. The posts are supported by the ceiling girder below. The ceiling girder size could not be verified.

- Replacement of the roof framing is required given the inadequate sizing and connections. Reinforcement is not likely to be cost efficient.

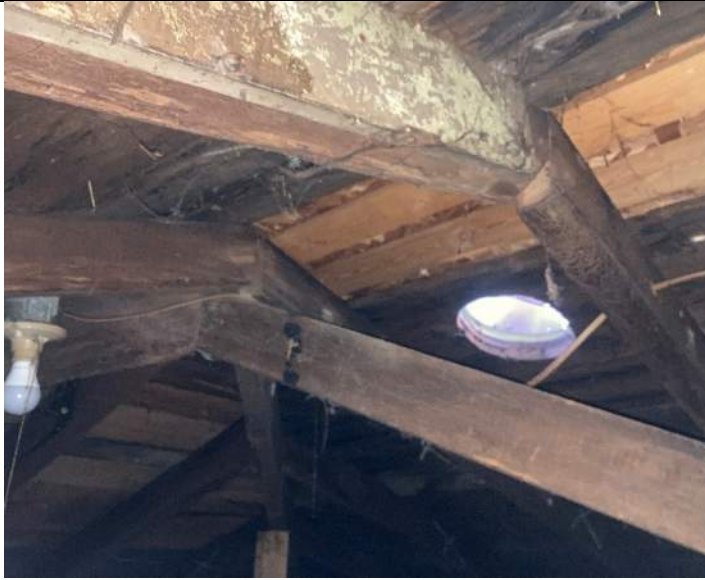
Addition: Roof Framing

- The hip beam connection is not adequate as no ridge board is present.
- A ridge board is not present between the rafters to provide an adequate connection.
- Vertical deflection was observed from the outside adjacent to the main area.

- Replacement of the roof framing is required given the inadequate sizing and connections. Reinforcement is not likely to be cost efficient.

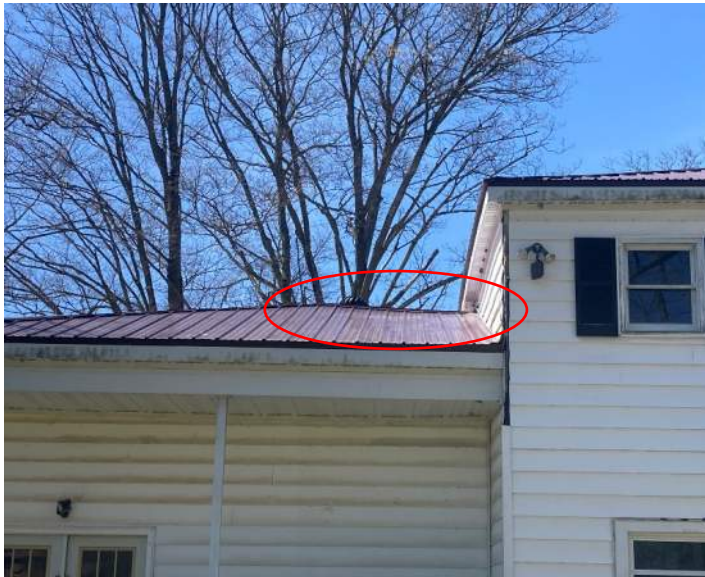
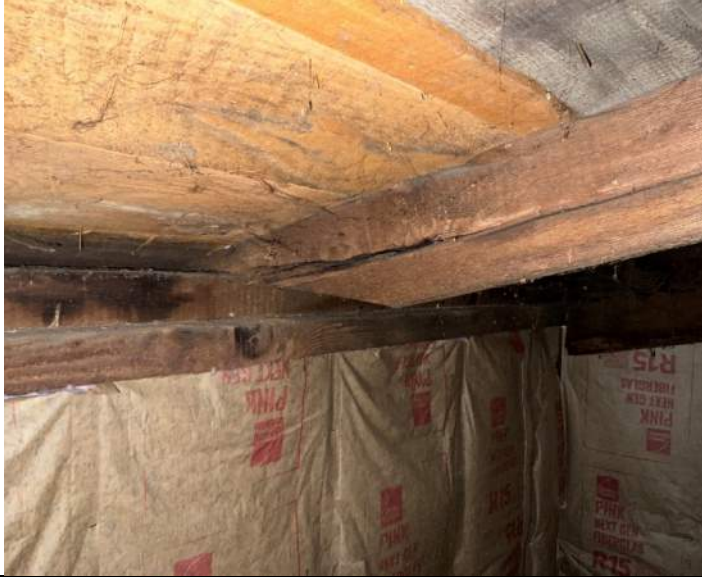
Addition: Roof Framing

- The rafters do not have adequate bearing at the wall top plate. Cracking and splitting are present in over half the rafters.
- The hip beam (not shown) also has inadequate bearing and is split at mid depth.
-

- Replacement of the roof framing is required given the inadequate sizing and connections. Reinforcement is not likely to be cost efficient.

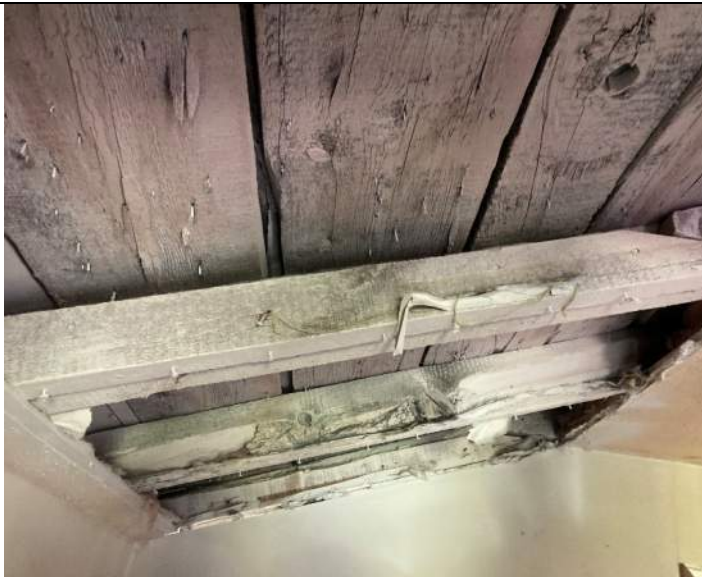
Main Area: Roof Framing

- The 3"x5" roof joists are spaced at 27" are undersized for the loading, span, and spacing.
-

- Replacement of the roof framing is required given the inadequate sizing and connections. Reinforcement is not likely to be cost efficient.

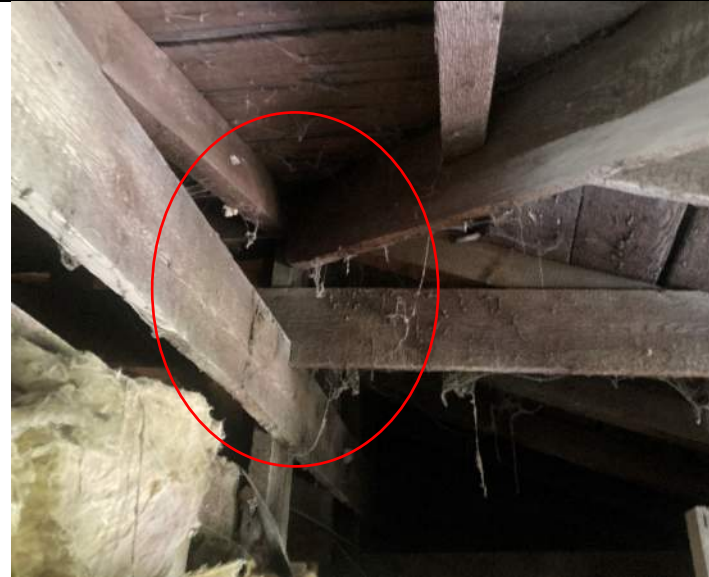
Main Area: Roof Framing

- The hip beam connection does not appear to be adequate.

- Replacement of the roof framing is required given the inadequate sizing and connections. Reinforcement is not likely to be cost efficient.

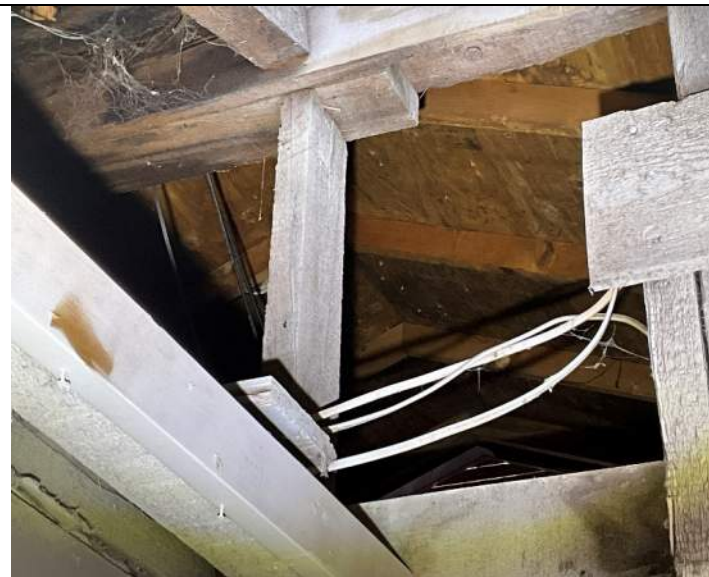
Main Area: Roof Framing

- The center framing appears to be 2x4 rafters at more than 24" spacing.
- A ridge board is not present.

- Replacement of the roof framing is required given the inadequate sizing and connections. Reinforcement is not likely to be cost efficient.

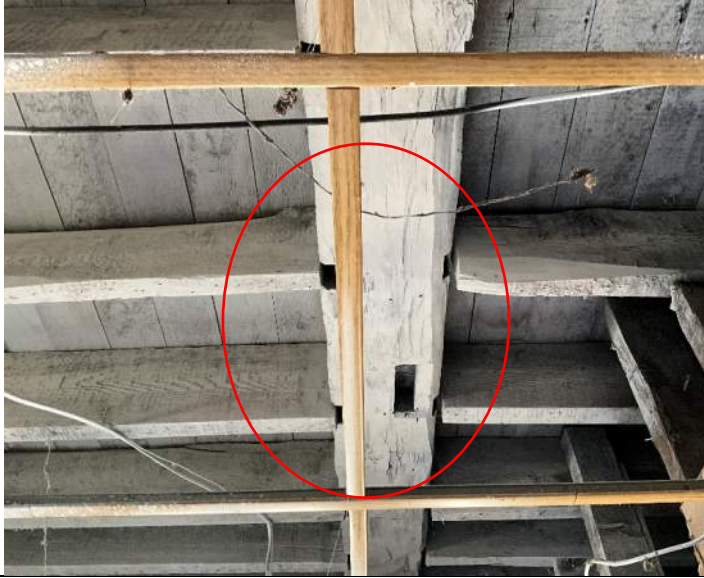
Main Area: Second Floor Framing

- The joist size and spacing is adequate for the loading and span.
- The joists appear to have pulled away from the north timber girder resulting in a loss of bearing.
- Cracking/splitting was observed in the joists due to the notches present at the girder bearing.

- Install joist hangers or;
- Install new engineered lumber girders on each side of the existing timber girder.

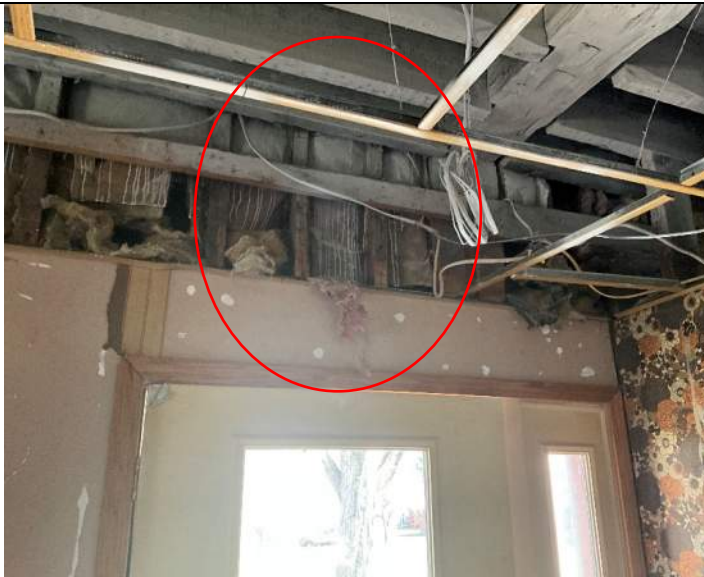
Main Area: Second Floor Framing

- The north timber girder is supported on a wood header over the entry door. The header does not appear to be adequately sized per current code.

- Install an engineered header on adequate supports to the foundation wall.

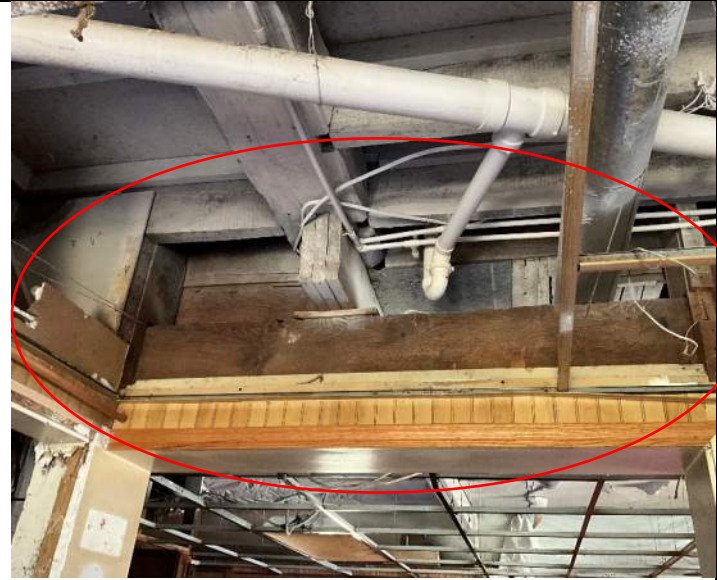
Main Area: Second Floor Framing

- The timber girders are supported on a wood header over an opening. The header (double 2x8) is not adequately sized per current code.

- Install an engineered header on adequate supports to first floor. The supports will need to extend to the foundation level.

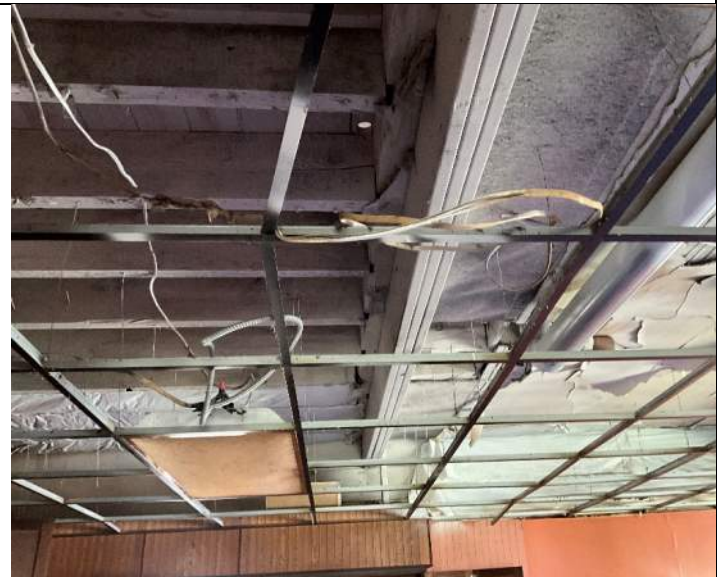
Main Area: Second Floor Framing

- The south timber girder has been previously reinforced with a 3 ply, 2x10 girder.

- The 3-ply girder shall be replaced with an engineered girder.

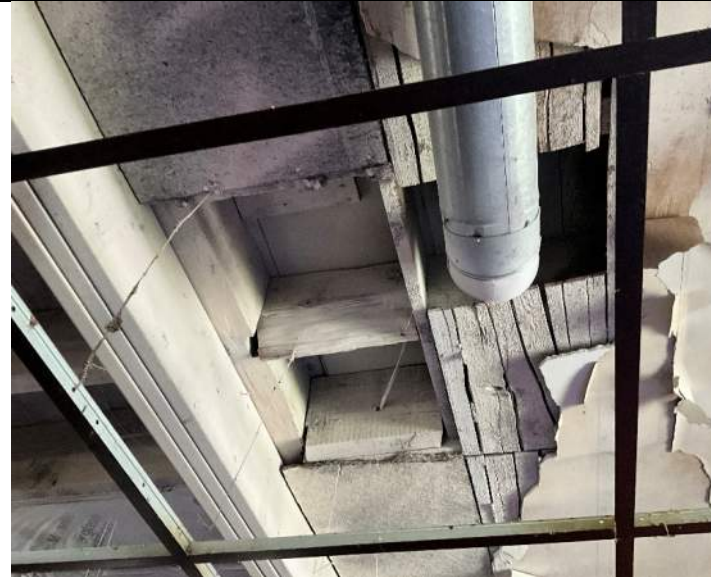
Main Area: Second Floor Framing

- An inadequate header was installed on the southwest area. The main joists were cut and a single, 2x header was installed and toenailed into the adjacent joists.

- The header shall be replaced with a 2-ply header. Additional sister joists will be required at the header ends.

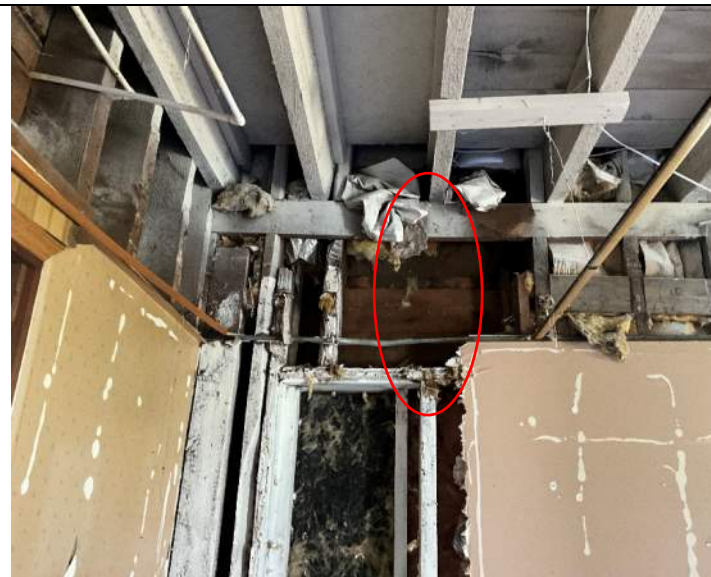
Main Area: Second Floor Framing

- A bearing stud is missing from the wall framing.

- Install a new 2x stud under the joist.

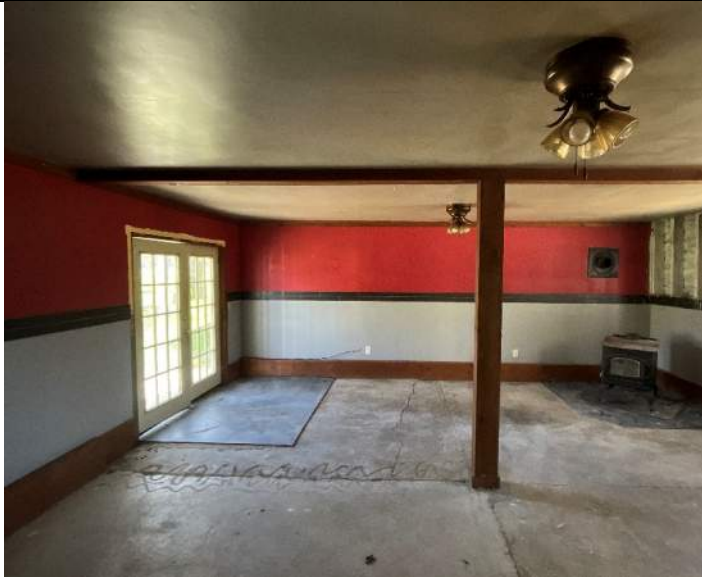
Addition: Second Floor Framing

- No access was available to determine the girder size supporting the roof posts above.
- No access to the crawlspace below.

- No additional work required.

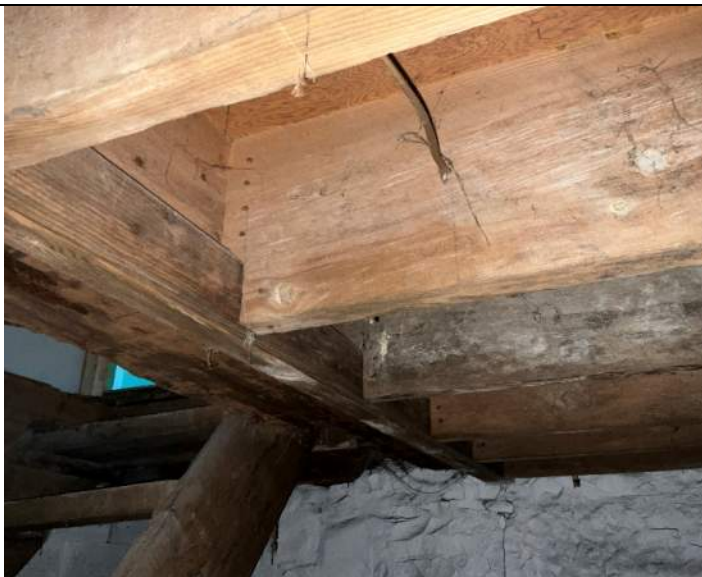
Main Area: First Floor Framing

- The 2x12 joists are supported at the center bearing with a ledger strip nailed to the girder.
- A newer 2x12 girder was installed adjacent to the existing timber girder.

- Joist hangers shall be installed to replace the ledger strip. Cracking in the joist may still occur through use.
 - Alternatively, bearing support (beam/posts or wall) can be installed under the joists.

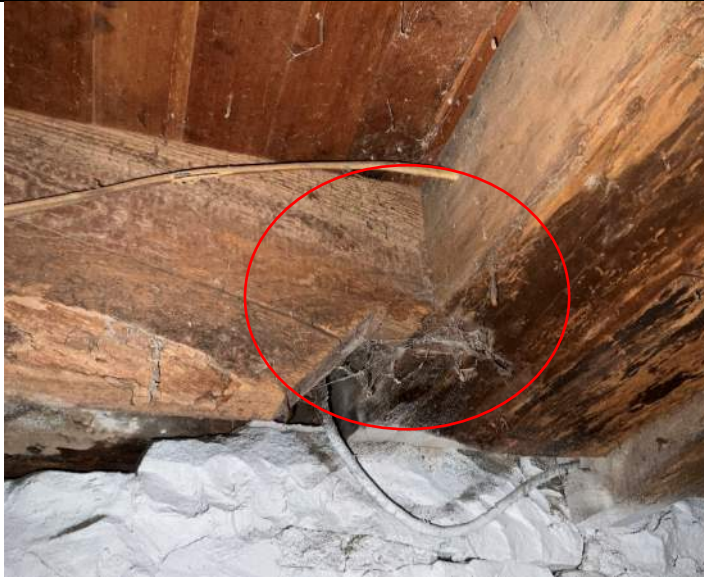
Main Area: First Floor Framing

- A joist under the stair landing has no bearing due to a notch in the joist and deterioration of the girder.

- Provide a post support under the joist.

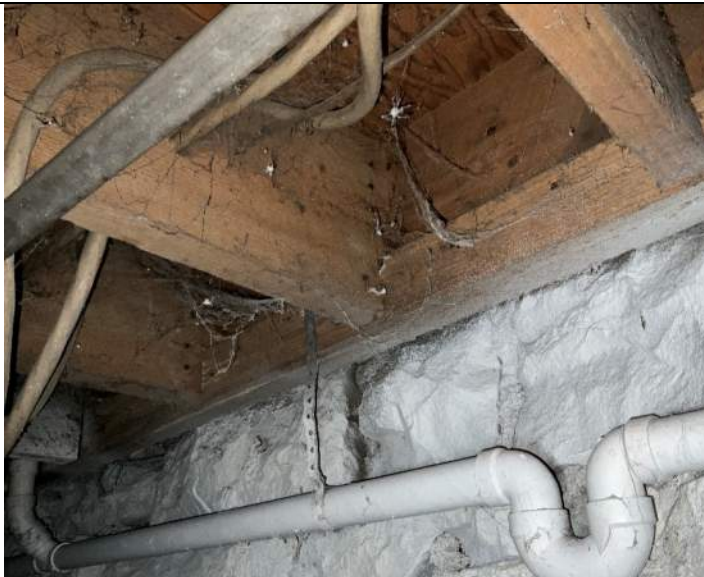
Main Area: First Floor Framing

- The south bearing condition is not typical. It appears a newer 2x12 girder was installed and nailed to the existing foundation wall. The girder is not supported by any post system.
- The joists are supported by a ledger strip.

- Bearing support (beam/posts or wall) shall be installed under the joists.

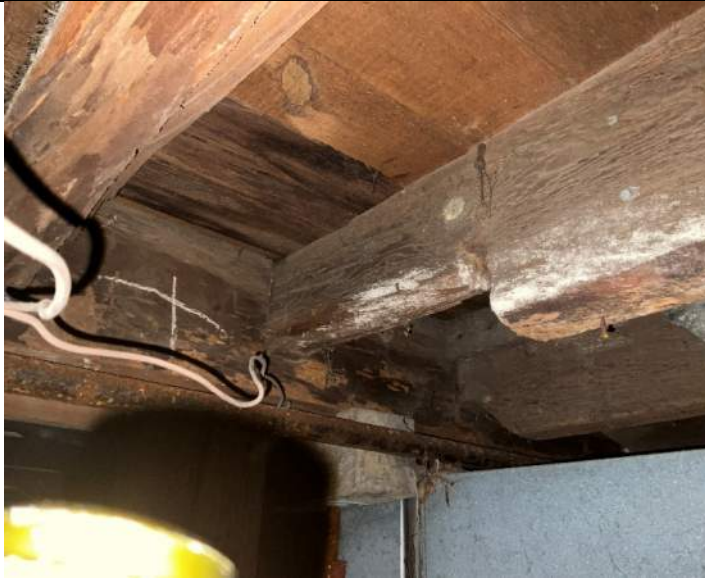
Main Area: First Floor Framing

- In the north area, approximately six joists have deteriorated from moisture and/or pest damage.
- A few of the joists have had additional 2x framing installed adjacent.

- 2x12 joists shall be installed adjacent to the deteriorated beams.
 - The joists shall be installed with joist hangers.

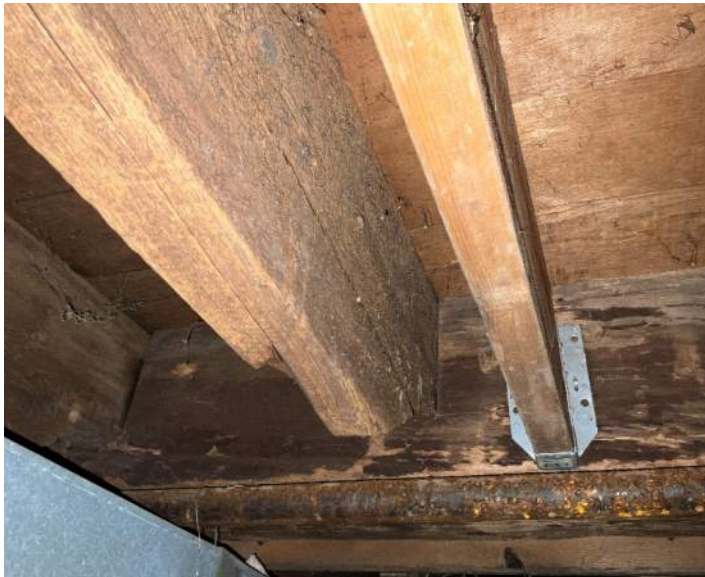
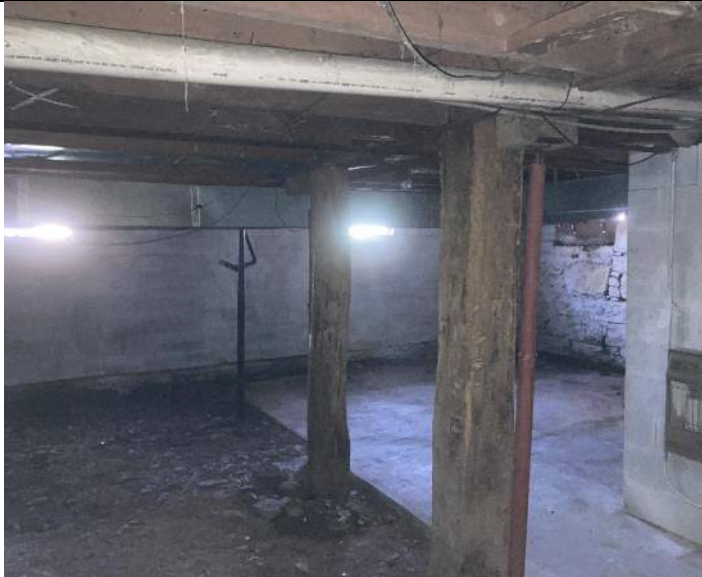
Main Area: First Floor Framing

- The center girder has various supports including jack posts, round timber, and rectangular timber.
- The timber shows signs of moisture deterioration.
- The jack posts are rusted and less than the maximum design capacity.
- The center timber girder shows signs of moisture deterioration.

- New foundations and new jack posts will be required. The posts will be spaced closer than currently installed based on engineering calculations.
 - Alternatively, a full-length bearing wall with concrete wall footing could be installed.

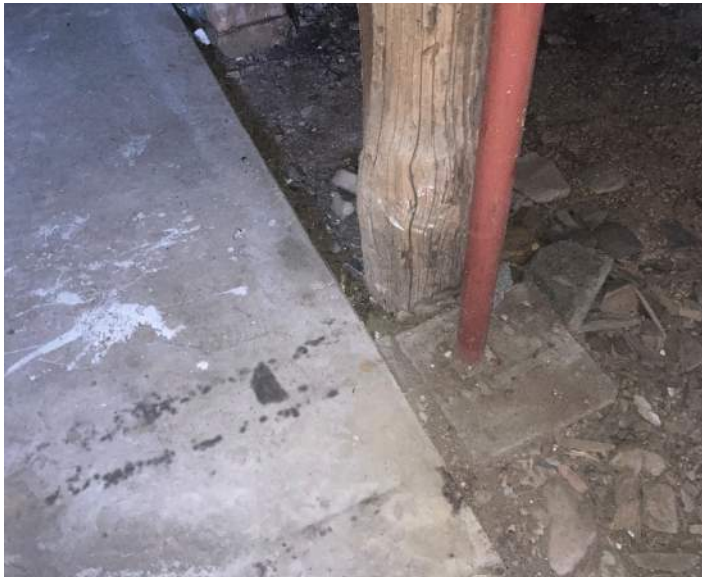
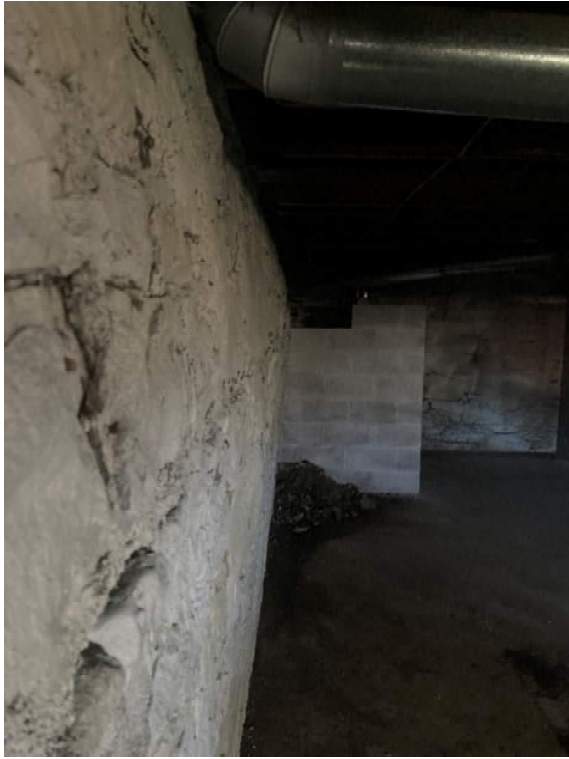
Main Area: Foundation Wall

- The north stone foundation is bowed approximately 6" near mid-height.
- The mortar joining the stone has deteriorated.
- The northwest and south west corners are not sealed and open to the exterior.

- The foundation wall requires replacement like the west and south walls.
- Any openings shall be sealed through repointing.
