Subject: Request for 5010 Post Inspection Written Response

August 18, 2021

RE: Michael J. Smith Field (MRH)
5010 Airport Data Collection Program

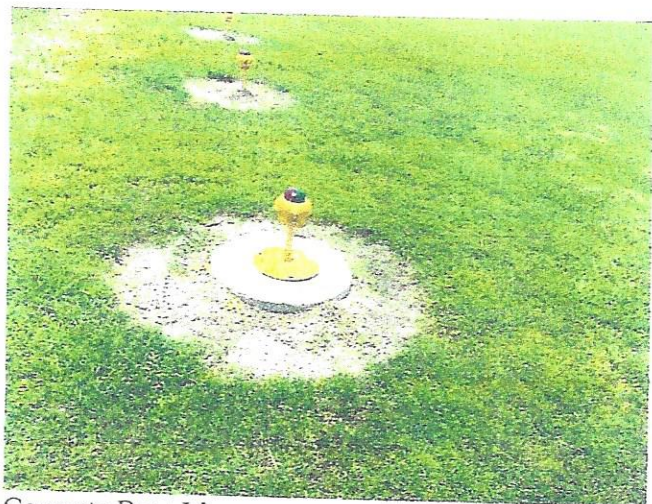
- All concrete bases, whether for signs, ducts, NAVAIDS, or lighting should be at grade.
- The taxiway from Runway 14 to Runway 8/26 has failing pavement and vegetation in cracks.
- Only Taxiway B is identified with signs. The other taxiways are not labeled.
- There are many non-standard signs in taxiway and runway safety areas. There are some non-standard signs on metal (non-frangible) posts in the vicinity of the hangars.
- The supplemental windsock was faded.
- The beacon could not be checked at the time of inspection.

Concrete Base Lip

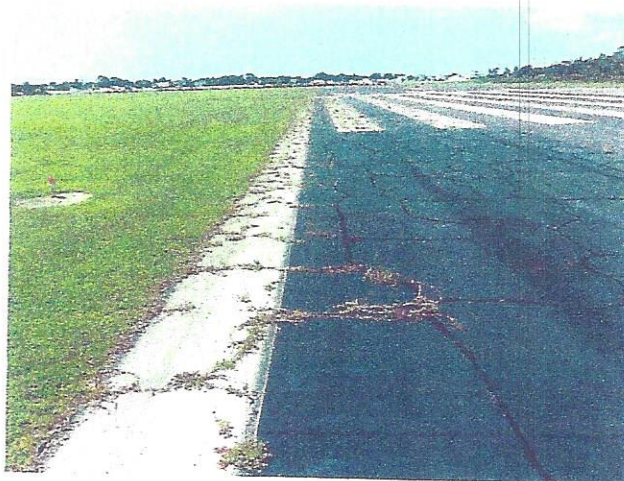
Discolored markings Grass Encroachment

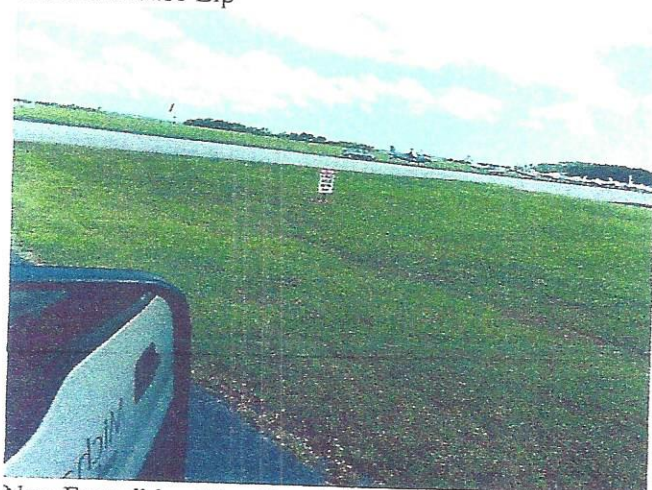
Non-Frangible - Non-Standard Sign

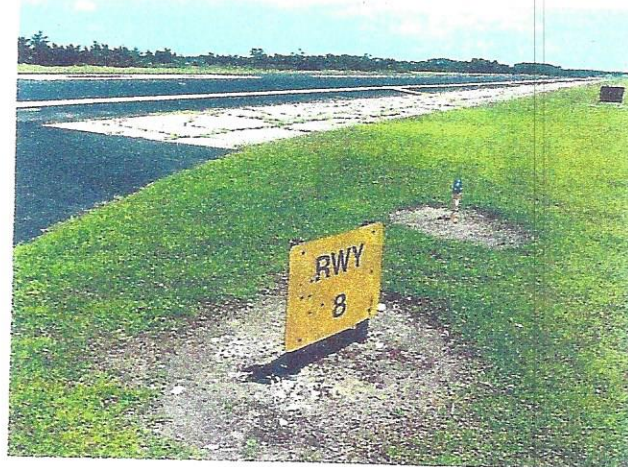
Non-Standard Sign

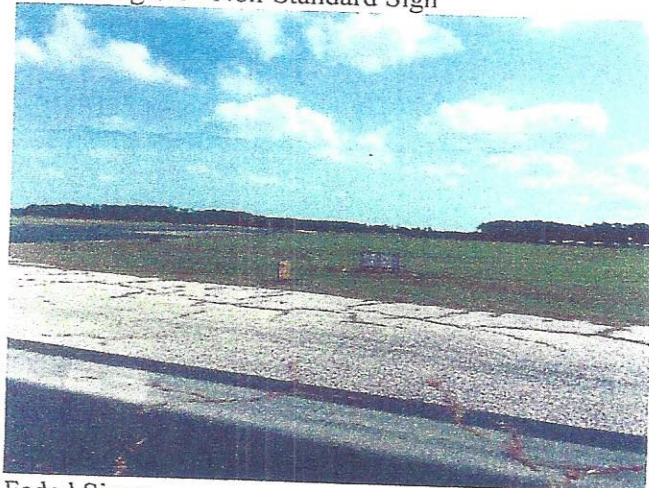
- A few signs are faded and/or delaminating including the ramp sign at Runway 14/32 and the Taxiway B sign going to Runway 26.
- The existing 110 cautionary remarks listed in the Airport Master Record were still applicable at the time of this inspection.
- Due to weather conditions at the time of the inspection, there could be no observation made concerning possible runway ponding issues.
- The aiming angle of the PAPIs should be periodically checked and a log maintained verifying those inspections.
- Effective January 1, 2009, airport managers are to annually update the airport's based aircraft under the National Based Aircraft Inventory Program (done online at www.basedaircraft.com) and the last update was on August 12, 2019 by Renee Rogers.

Faded Signs

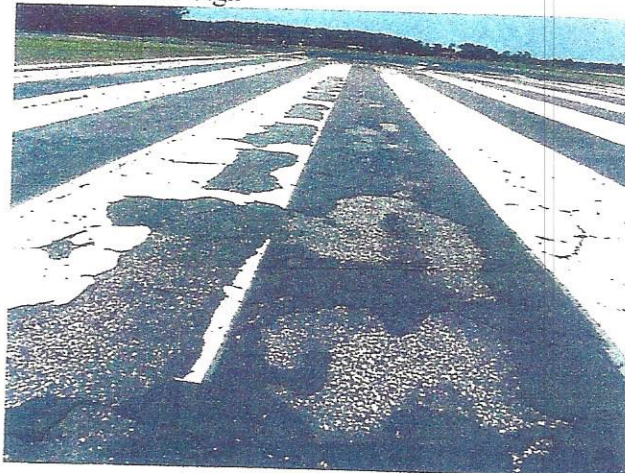
Pavement Breaking up

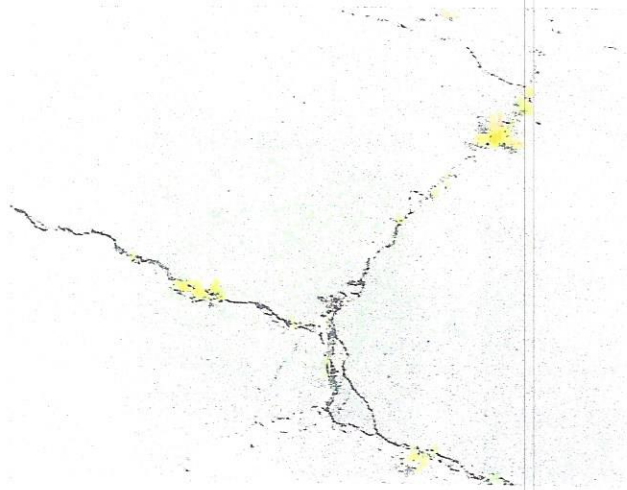
- Runway 14/32 has block cracking, pavement cracks and holes with vegetation and grass encroaching on the pavement ends.
- The aggregate is beginning to become loose and there is some F.O.D.

Pavement Cracking Runway 32

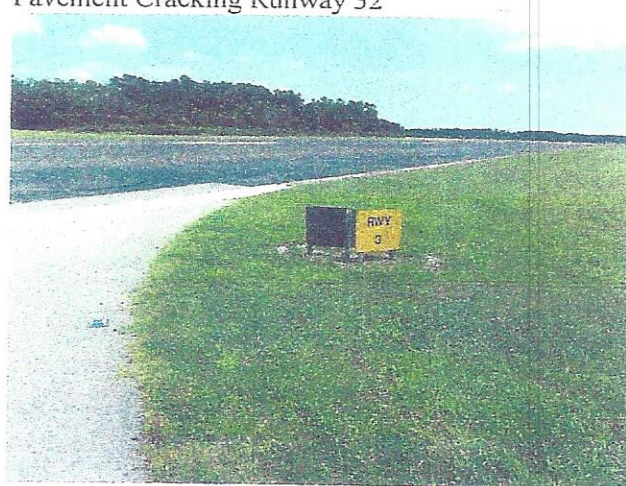
Non-Standard Signs
