# SOUTHEAST KENTUCKY COMMUNITY AND TECHNICAL COLLEGE

Whitesburg Campus – Bridge Repairs  
470-C9DX STRUCT

RE: Southeast Kentucky Community and Technical College  
Whitesburg Campus – Bridge Repairs  
2 Long Ave.  
Whitesburg, KY 41858  
B+K Project Number: 19204  
KY job #: 470 – C9DX STRUCT

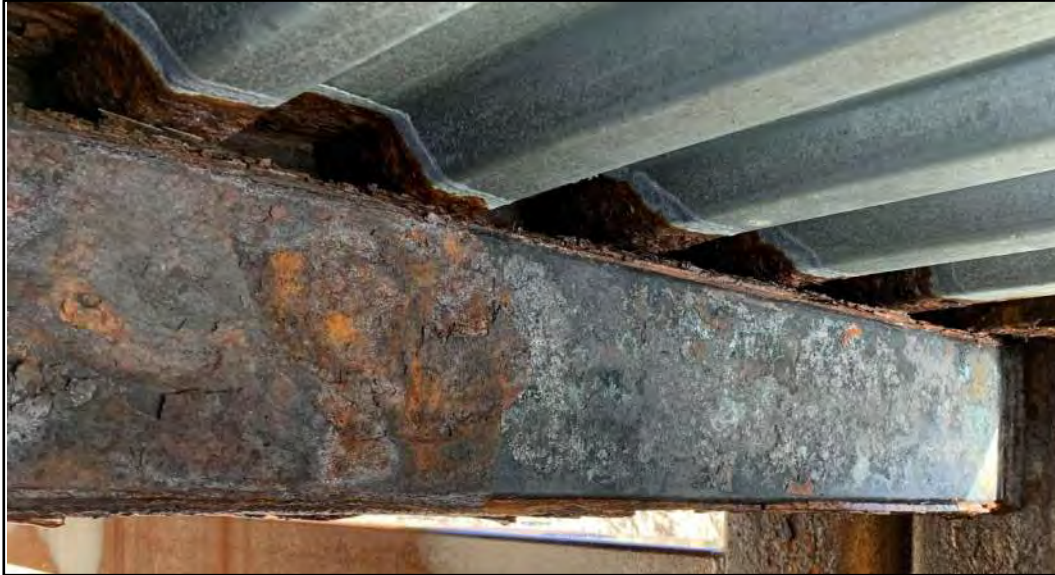
*Image 2: Delamination Removed from Cross Member*

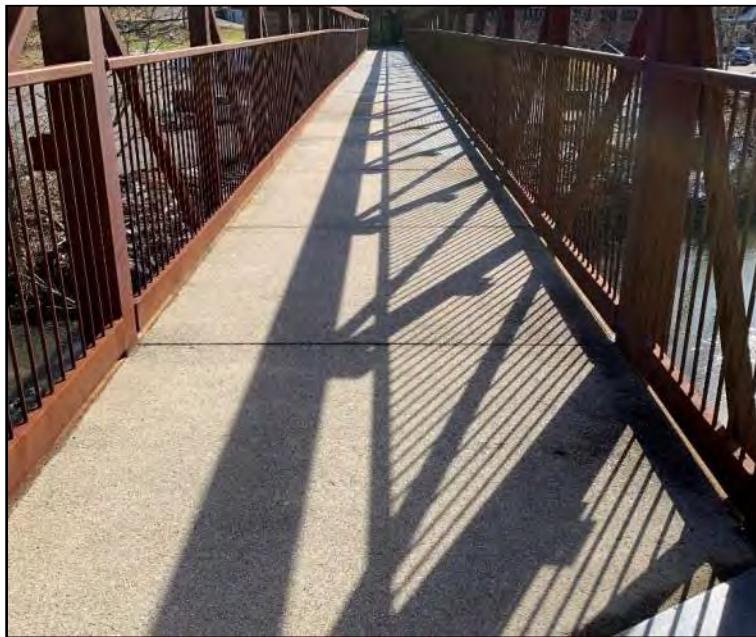
The walking surface is exposed concrete with no apparent sealer or traffic membrane. The concrete surface has a broom finish with sawn construction joints at ~7'-6" on center with no sealer in the joints. The walking surface is constructed with 2 1/2" concrete over non-composite 1 1/2" galvanized metal deck (4" total thickness). The bridge spans between concrete abutments and piers with no apparent sealer applied to their surface. The Southeast span (~80'-0") is over a parking lot and the Northwest span (~100'-0") is over the North Fork Kentucky River. The height to the underside of the bridge ranges from ~7'-6" at the Southeast span and ~17'-9" at the Northwest span. Photographs of the bridge and its components were taken, some of which are included herein.

*Image 4: Bridge Walking Surface*

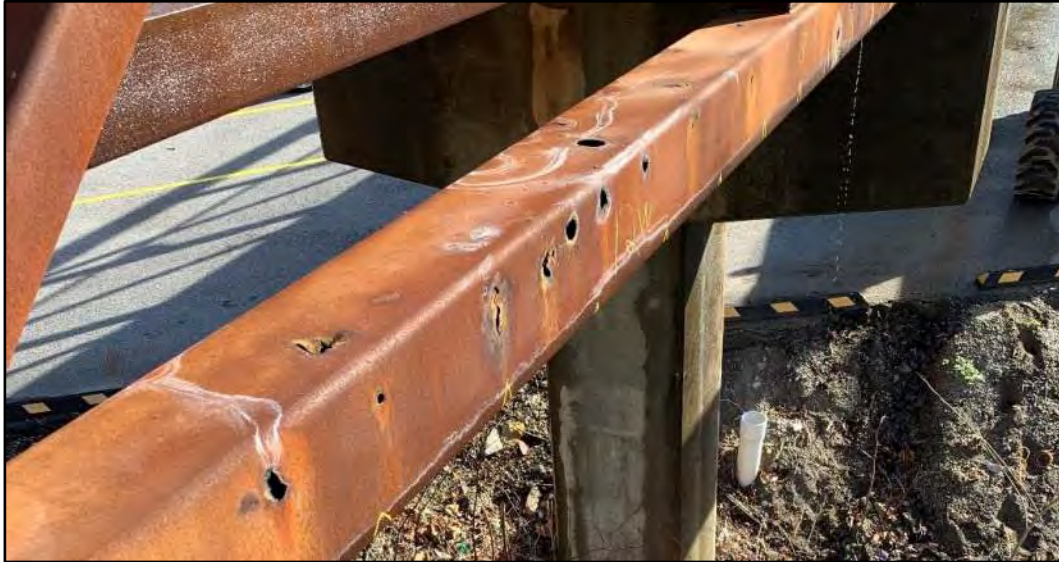
The truss bottom chords are in moderate to poor condition. The truss bottom chords have consistent mild delamination on the underside of the tube for the full length of the bridge on both chords. Localized corrosion resulting in significant loss of section was found in the West bottom chord of both span 1 (North span) and span 2 (South span). In span 1 of the west bottom chord holes through the section are located on the outside face and on top of the tube. Holes range from 1" to 3" diameter spaced approximately 8 inches on center over a length of approximately 40 feet. Span 2 has holes approximately 1 inch in diameter spaced at 12 inches on center over 15 feet. The spacing of the holes is random, the above spacing is approximate. Weep holes are not present in the bottom chords, resulting in water to be retained in the closed section. Approximately 5" of water and ice was retained in the bottom chord at the time of our site visit.

We believe this is caused by the improper drainage of the walking surface above. The salt/water combination is draining onto the top of the steel bottom chords and causing the chords to rapidly deteriorate. Also, the bridge generally slopes to the west side of the deck, causing the water to drain to the West chord more than the East chord.

*Image 6: Span 1, West Bottom Chord Deterioration*

1. The East and West bottom chords shall be replaced for the full length of the bridge. The existing bottom chords do not have weep holes to allow for water to drain out of the closed member section. In the new bottom chords, provide 1/4" diameter weep holes centered in the bottom of the section at 48" on center.

- o Bottom chord replacement quantity: 360 linear feet.
  - o Weep hole quantity: 100 holes.
2. All cross members located at splices and bearing locations shall be replaced.

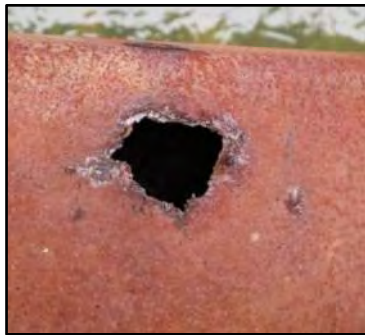
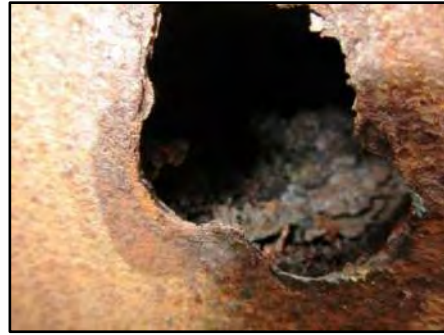
*Image 7: Close-up of Holes through Bottom Chord*

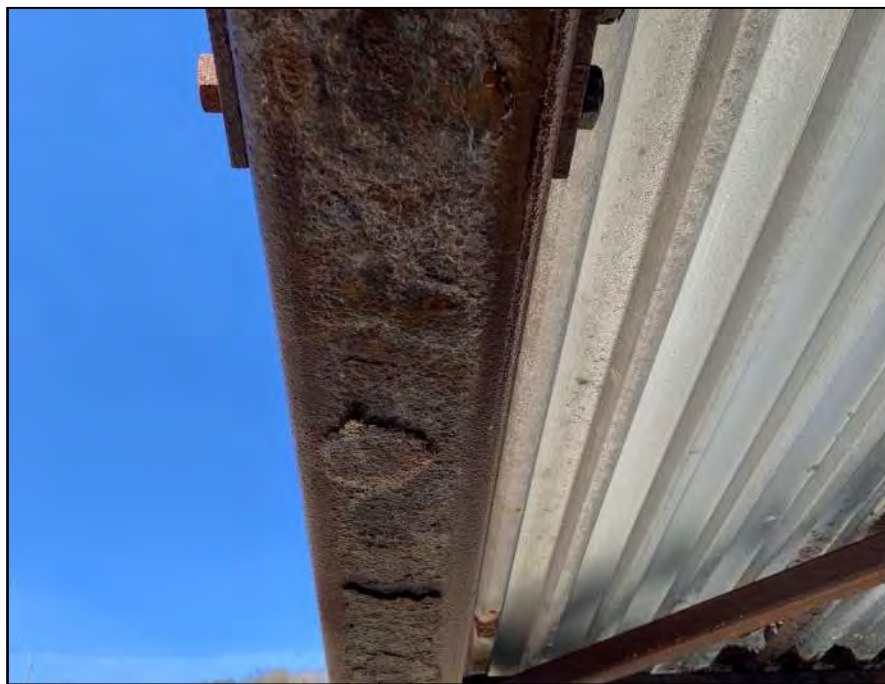
*Image 8: Underside of Bottom Chord Delamination*

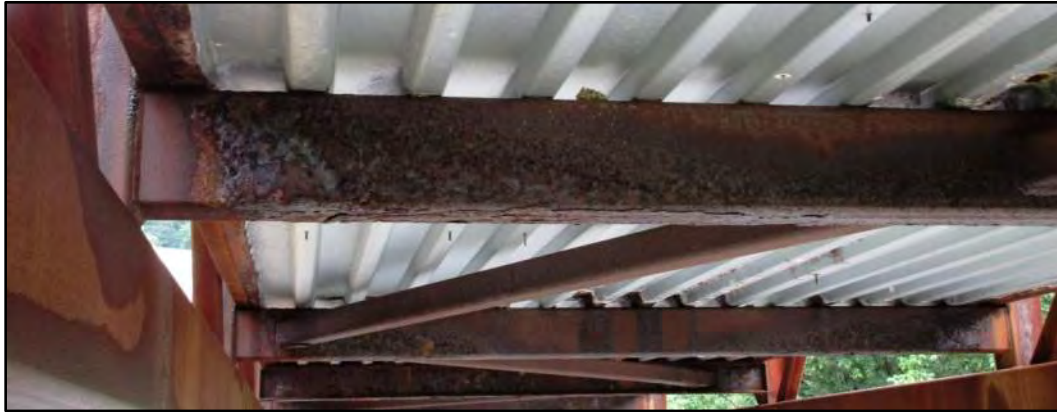
The condition of the cross members are consistently corroded and delaminating at both ends where they connect to the trusses. The bridge is spliced in two locations and has three end bearing conditions. Each end bearing condition and splice is experiencing infiltration of water through the slab joint and significant corrosion of the cross members.

We believe this is due to the bridge improperly draining over the edge of the walking surface and corroding the end of the cross members. The lack of joint sealants at the splice and bearing locations is causing extra water to corrode the members below these locations.

*Image 9: Cross Member Corrosion*

- o Cross member replacement quantity: 64 linear feet.
3. All cross members not located at splices or bearing locations shall be blast cleaned and painted with a rust-inhibitive paint.

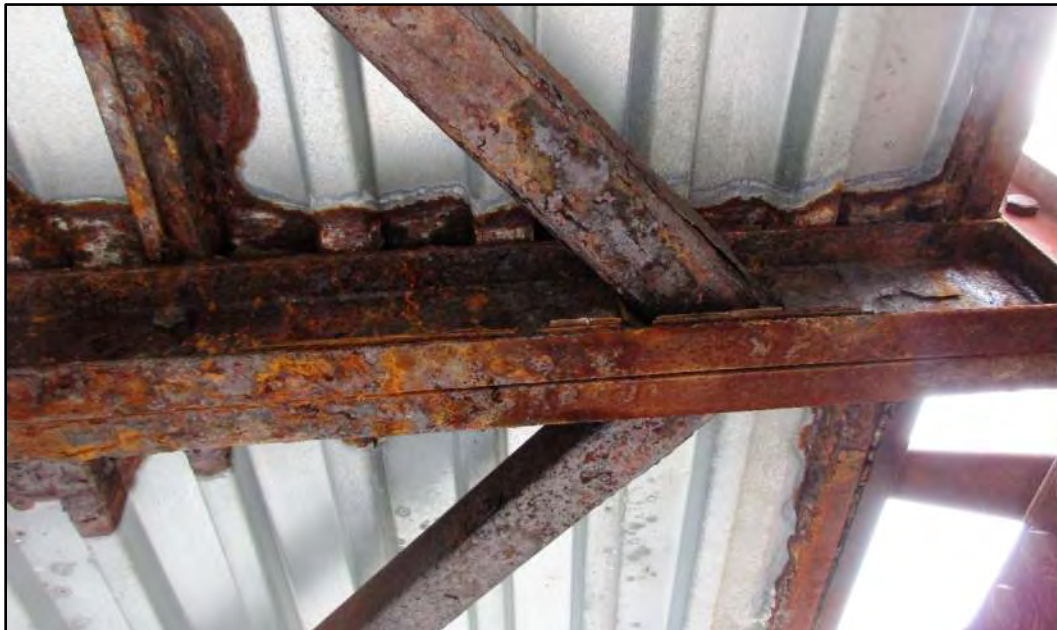
In general, the condition of the lateral braces below the deck are fair. The lateral brace members are corroding on all sides of the section at the ends connected to the cross members. Deterioration is currently localized to the surface of the members, deterioration has yet to greatly impact the welded connections.

We believe this is caused by the lack of joint sealant in the concrete slab on deck sawn joints. Water is infiltrating through the sawn joints and corroding the ends of the lateral braces.

*Image 10: Lateral Bracing Corrosion*

- o Blast cleaning quantity: 240 square feet.
  - o Rust-inhibitive painting: 240 square feet.
4. Where lateral bracing is showing surface corrosion and light delamination, blast clean and paint with rust-inhibitive paint.

- o Blast cleaning quantity: 200 square feet.
  - o Rust-inhibitive painting: 200 square feet.
5. The existing concrete slab over metal deck shall be removed and replaced. A penetrating concrete sealer shall be used on the new concrete slab and all joints shall be properly sealed to prevent water infiltration. The following are options for replacement:

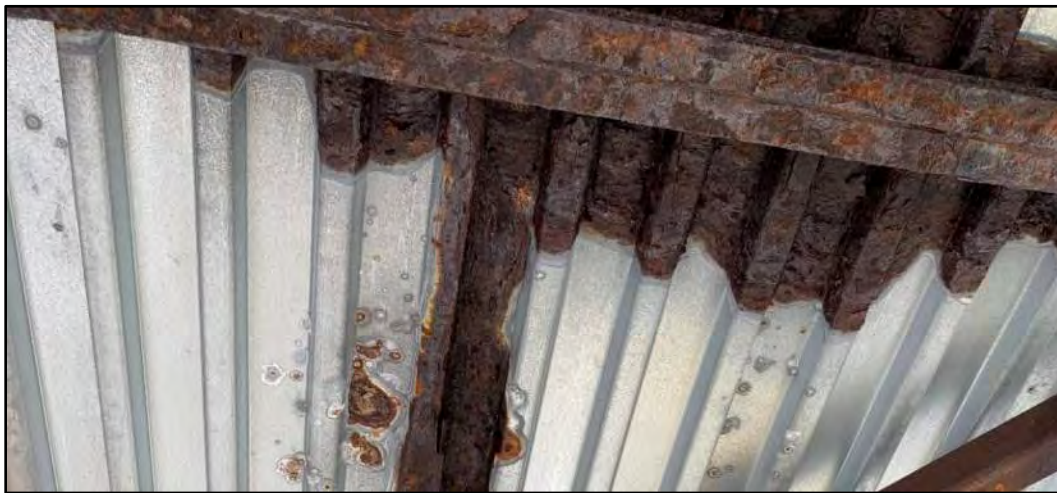
The concrete slab over the steel deck is in fair condition. All bearing locations of the galvanized steel deck are experiencing corrosion. Bearing locations include the ends, intermediate supports, and all edge conditions at the perimeter. All locations are experiencing moderate to severe corrosion with some localized areas experiencing full loss of the steel deck.

*Image 11: Underside of Deck Corrosion*

This issue cannot be resolved without full replacement of the concrete slab on deck.

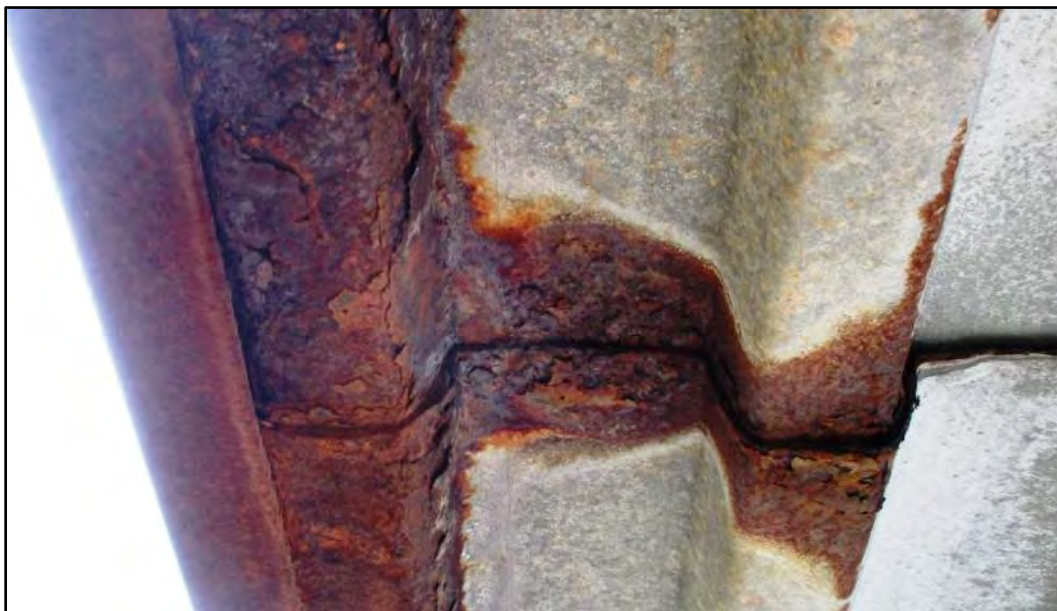
We believe the deck is corroding at these locations due to the interaction between the galvanized steel and weathering steel. Galvanized steel rapidly deteriorates when in contact with weathering steel. The weathering steel protective rust coating constantly corrodes the galvanized coating until it is gone and the steel below deteriorates. Another cause is the lack of a traffic membrane allowing water to infiltrate through the sawn joints and corroding the steel deck.

*Image 12: Weathering Steel/Galvanized Deck Interaction*

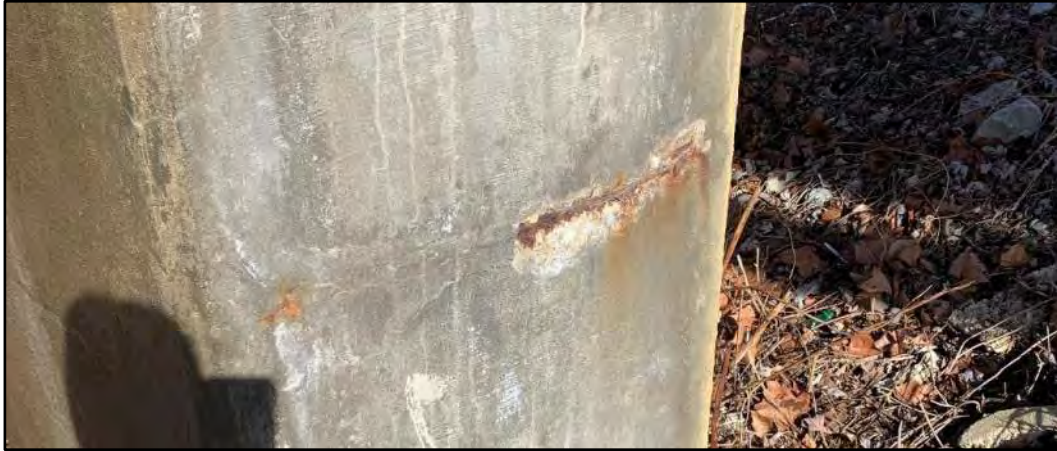
Overall, the concrete piers and abutments are in good condition. A few locations are experiencing delamination of the concrete and exposed corroded rebar. The south pier between spans 1 and 2 has an exposed section of reinforcement the full width of the Pier. Further exposure to the elements will result in additional loss of concrete and reinforcement section.

We believe this is a result of inadequate cover for the reinforcement, leading to accelerated corrosion of the reinforcement.

*Image 13: Concrete Pier Spall*

- Destructive testing holes to be patched: 15 locations.
- 7. Exposed rebar in the abutments and piers shall be repaired. Sawcut around the perimeter of the exposed rebar, undercut concrete to  $\frac{3}{4}$ " behind reinforcement, blast clean, prime, and apply repair mortar.

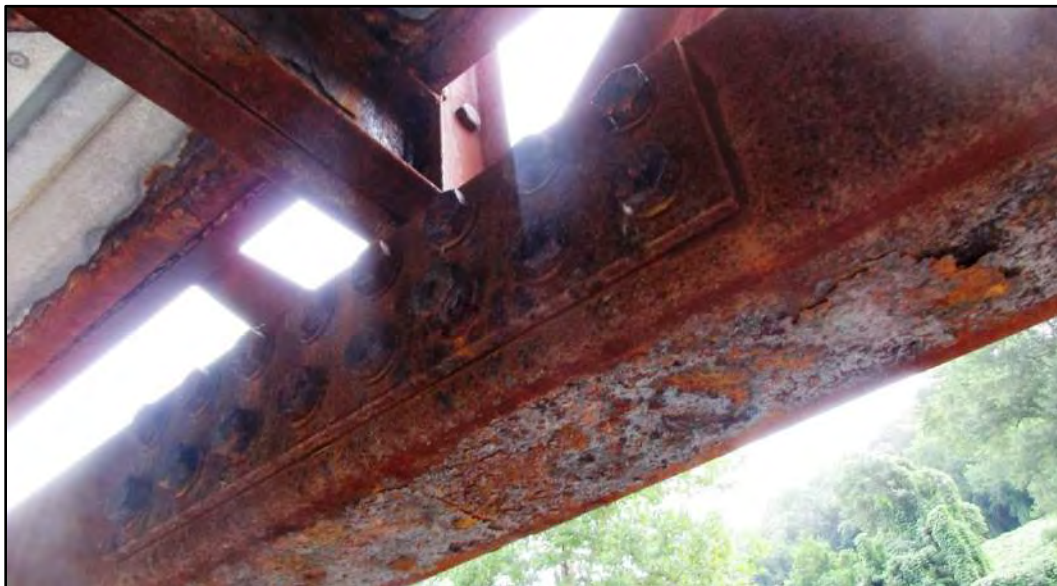
The condition of the bolts at the chord splices were not able to be inspected. Each splice has external cover plates with bolts that thread to an interior nut. Some surface rust was seen at the interior of the chord splice. We are concerned that the bolts are experiencing section loss and severe loss of bearing against the chord walls.

We believe this is caused by the lack of weep holes in the bottom chord, leading to the bottom chords collecting water.

*Image 14: Bottom Chord Splice Corrosion*

- Covering quantity: 1 lump sum
- 11. Due to the likelihood of the bolts corroding at the splices, we recommend reinforcing each splice.
  - Splice reinforcement quantity: 8 locations.

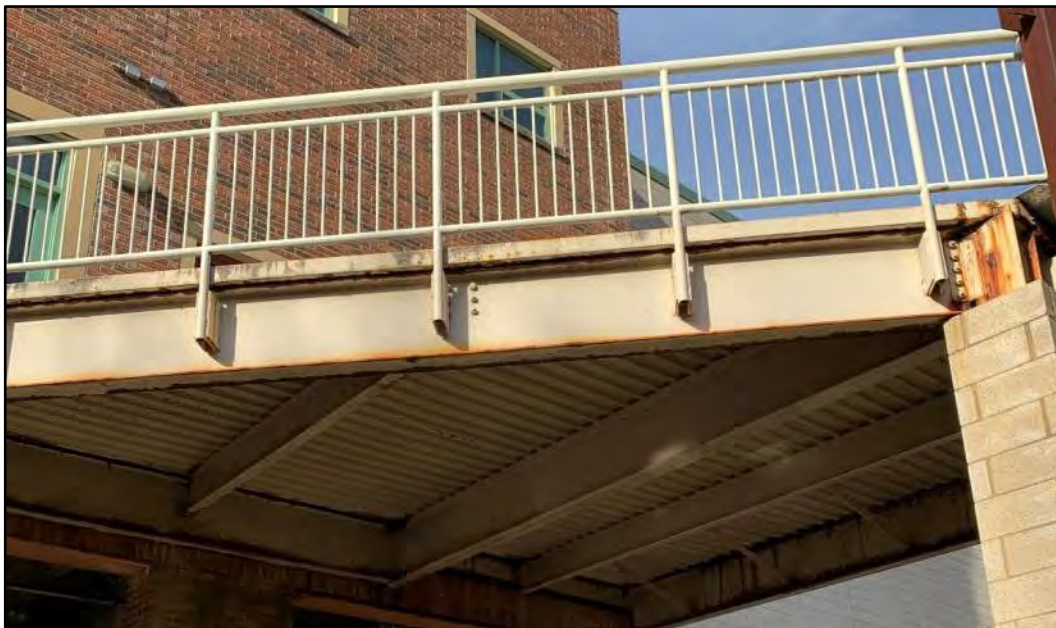
*Image 15:North Raised Landing*

The condition of the landing is fair. The steel beams are showing mild section loss due to corrosion of the top and bottom flanges around the perimeter of the landing. Some localized corrosion was observed at the underside of the deck and at bearing conditions resulting in approximate 90% section loss of the steel deck. The edge angle is experiencing surface rust where it is in contact with the beam top flange.

There is no immediate structural concern for the landing, though corrosion will likely continue without corrective action. It is our recommendation to remove the existing concrete slab on deck, blast clean all structural steel and paint with a rust-inhibitive primer and top paint. The slab on deck should be replaced with a formed slab and be sealed to prevent further water infiltration.

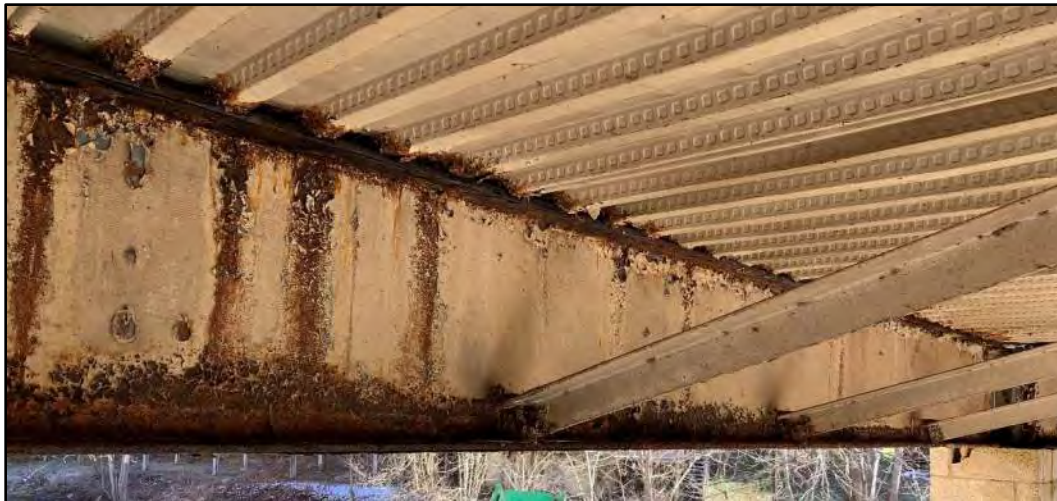
We believe the corrosion of the underside of the raised landing is due to no galvanizing used on the steel, no special detailing for exterior exposure, no sealant on the concrete slab, and concealed/trapped structure against the building with no weathering protection.

*Image 16: North Landing Underside Corrosion*

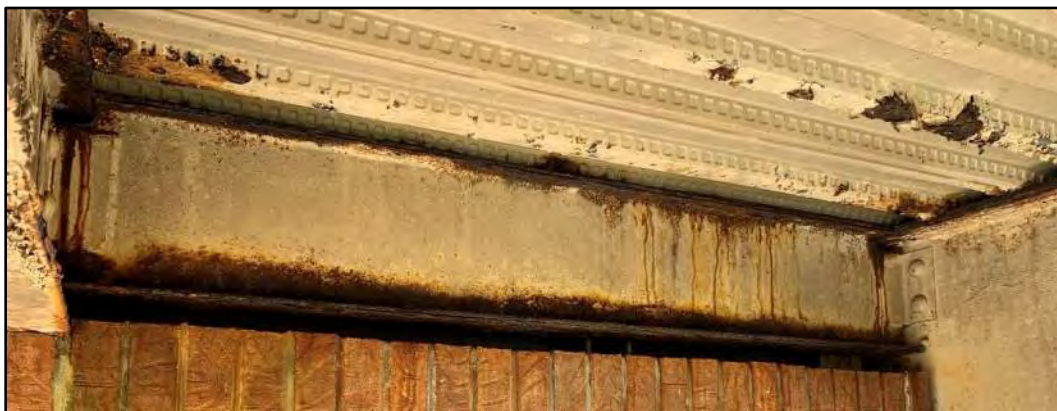
*Image 17: Beam Corrosion at Building Intersection*

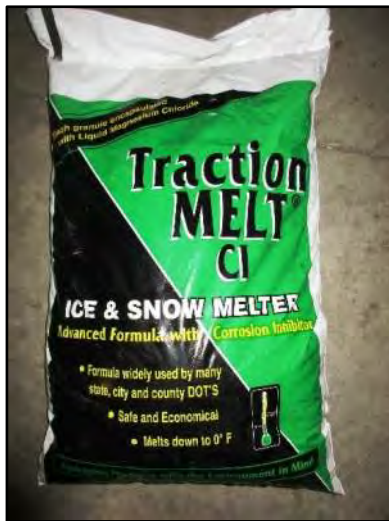
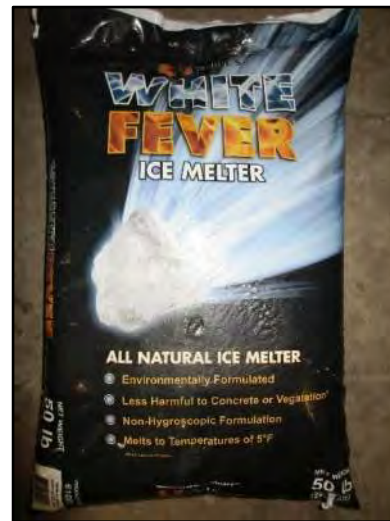
The use of de-icing salts to date have accelerated the deterioration of the steel structure. We were asked to determine whether the type of salt used had a greater effect than other salts. All de-icing products containing chlorides are corrosive. The salt brands being used per the maintenance staff are Traction MELT CI and White Fever Ice Melter, both salt brands being used on the bridge contain chlorides and are corrosive to the steel. The weathering steel is especially susceptible to the de-icing salts since it is constantly exposed raw steel.

Image 18: De-icing Salts

The use of de-icing salts and exposure to the elements will continue to deteriorate the pedestrian bridge and landing, even after replacement or remediation efforts are complete. Pressure wash cleaning should be performed each Spring to remove salts. It is the owner's responsibility to perform regular cleaning and maintenance on the protective paint coating and traffic membrane.
