Final Report for

KCTCS - LAUREL SOUTH CAMPUS FEASIBILITY STUDY SOMERSET COMMUNITY COLLEGE

Laurel South Feasibility Study

1 September 2023

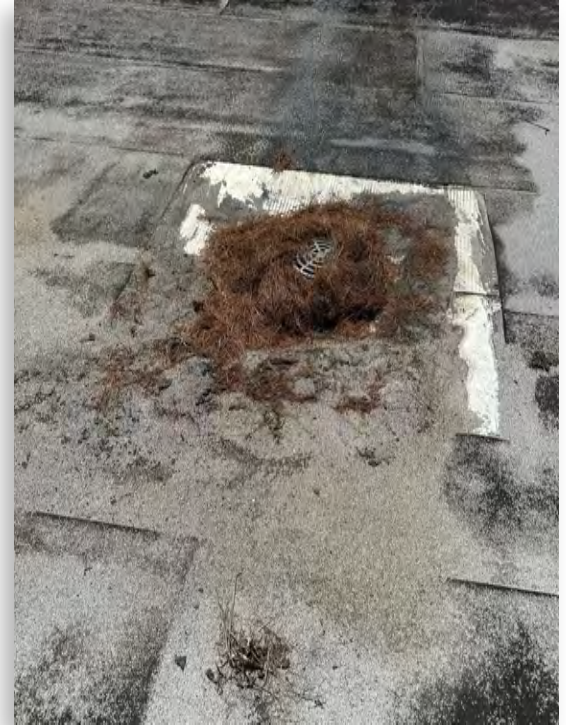
During WPA's site visit, the roof drains were covered with pine needles and deep piles of roof granules. (this can be seen in the photo to the right.) Additionally, there are blisters in the roof membrane visible beyond the drain.

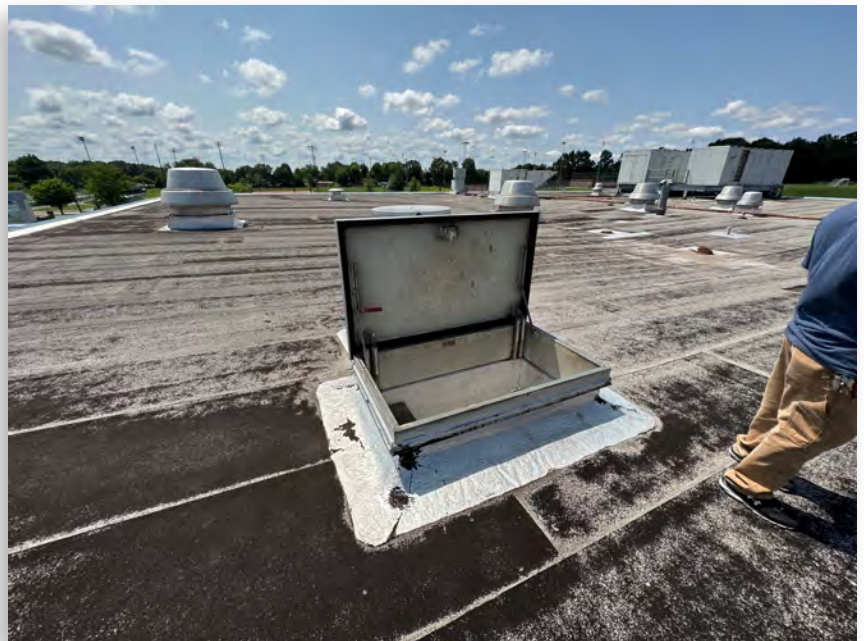
The loss of roof granules is very evident where there is frequent foot traffic on the roof. The area around the roof access hatch is nearly bare. A variety of low mechanical curbs likely to be affected by the increased thickness of the roof system in the background can be seen.

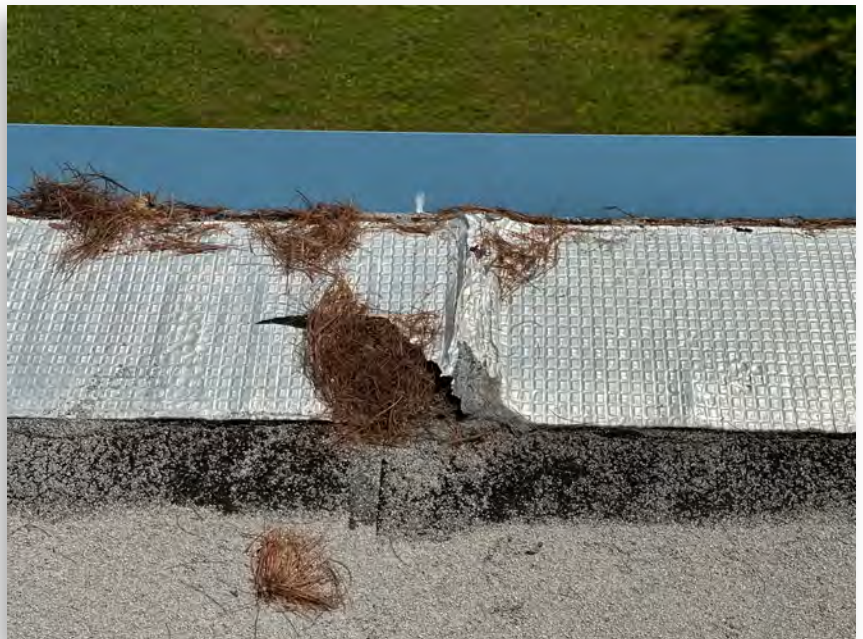
In other places, the flashing material is torn or missing. Here it appears to have snagged pine needles at the roof edge.

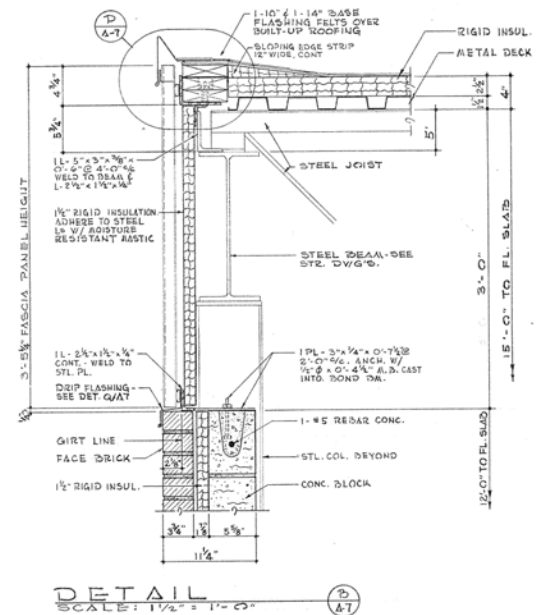
The detail at right is a typical roof detail from the construction documents for the 1975 addition. The detail shows the roof edge flashing and the 2½" of roof insulation called for in this system. Current IECC standards call for as much as 5" of continuous rigid insulation. It is also worth noting that the flashing is not designed to redirect water that has entered the wall system to the exterior. Any water that enters the wall from above will easily find its way into the wall cavity. (The construction documents have no details showing the installation of the relief angles.)

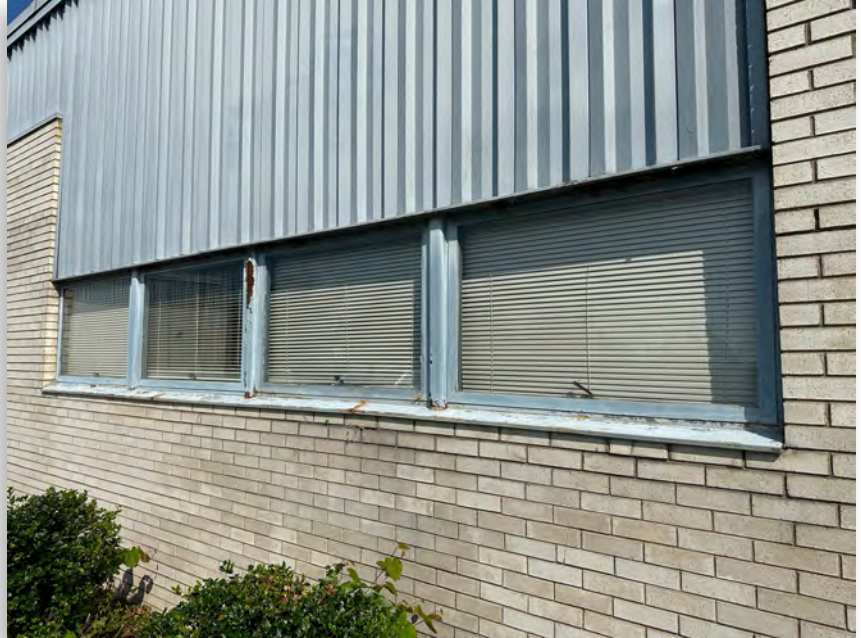
This is a typical steel window showing signs of rust in multiple places. These windows are uninsulated and not thermally broken allowing for thermal bridging that can cause condensation in the winter and summer. WPA recommends these windows be replaced with energy efficient ones. Note the discoloration in the bricks below the window and in a horizontal band at the left side near the window head. These are the signs that water is accumulating in the wall cavity.

The existing, steel, uninsulated windows should be removed, the openings properly flashed, and new, insulated and thermally broken frames with insulated, low-e glazing units installed. Exterior doors at main entries to the building should also be replaced with more inviting aluminum storefront frames and entry doors. The storefront systems should also be thermally broken and insulated and include insulated glazing in the sidelites and doors. Doors that are not part of a main entry (at shop areas, for example) should be replaced with new hollow-metal frames and doors that are insulated, thermally broken, hot-dipped galvanized and weather-tight. Any damaged lintels should be repaired or replaced, all rust removed from existing lintels and repainted. New lintels should be hot-dipped galvanized and painted. All of the large, over-head coiling garage doors should be replaced with insulated ones with new motors and rails. Jambs and heads should be repaired and prepped to allow the new doors to seal properly when installed.

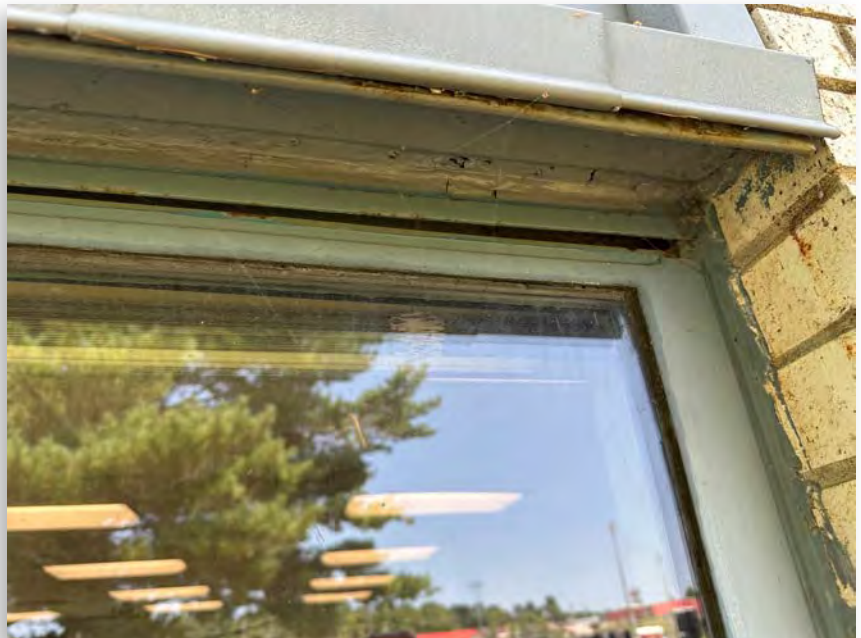
This steel window has a damaged sash that does not seal properly. There are signs of rust in the gap at the top.

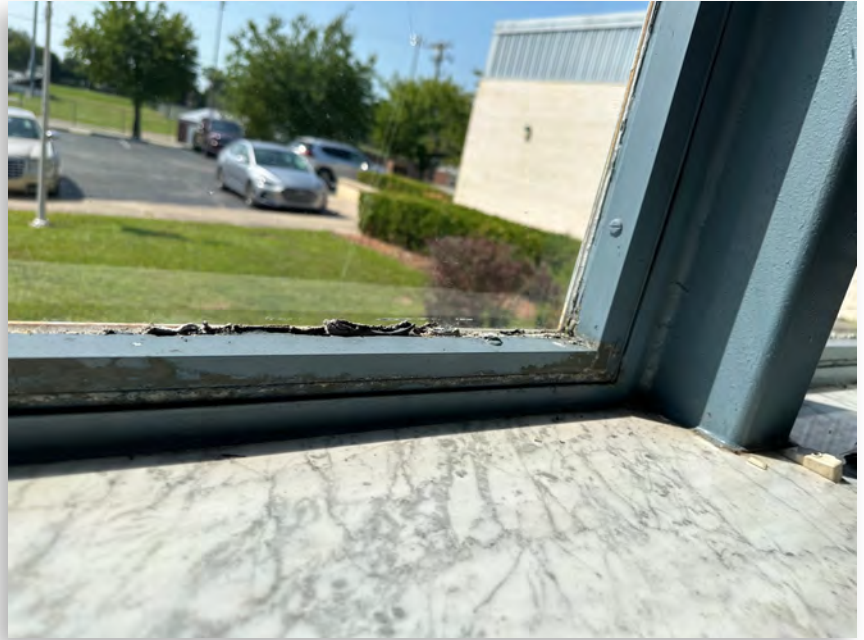
This image shows the deterioration of the glazing sealant in this window. The bottom of the sash is also showing significant wear.

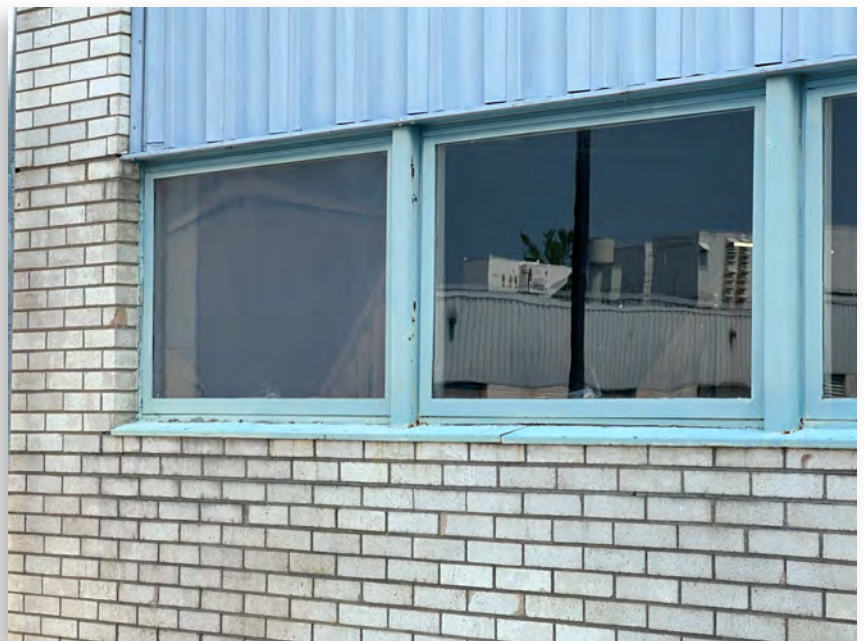
This image shows another window with rust in various places. This window also has a damaged sill that is allowing moisture into the wall cavity below the window. Note the gap between sill lengths under the middle sash.

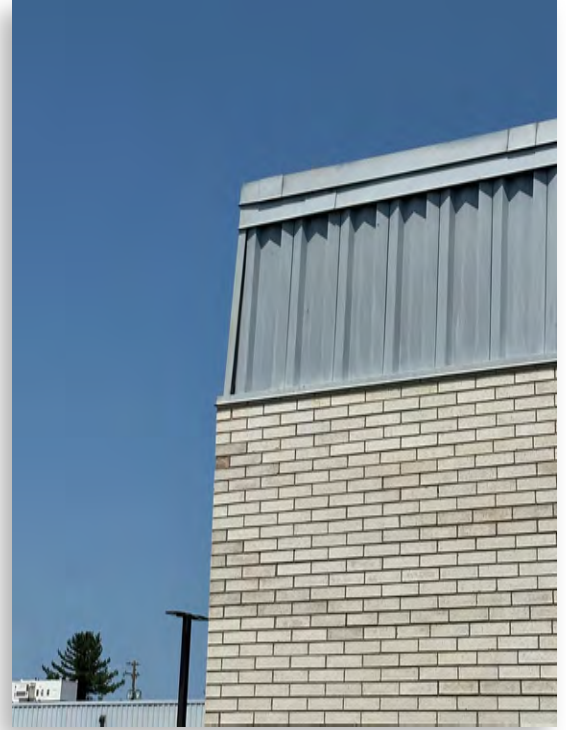
The deformation of the upper, metal-panel-covered portions of the building is shown here at the South corner of the original building. This is the most pronounced instance and may be partially due to the lack of masonry expansion joints on this portion of the building. There are bricks in many places that have spalled faces like the one five courses down from the top of the brick area.

WPA recommends replacing the metal panels at the tops of the walls to make sure they are flashed properly and weather-tight. In areas where there appears to be horizontal movement in the top portions of the wall, a structural engineer should evaluate the cause and whether it is a item for continued concern or the remnant of building settling that has stopped.

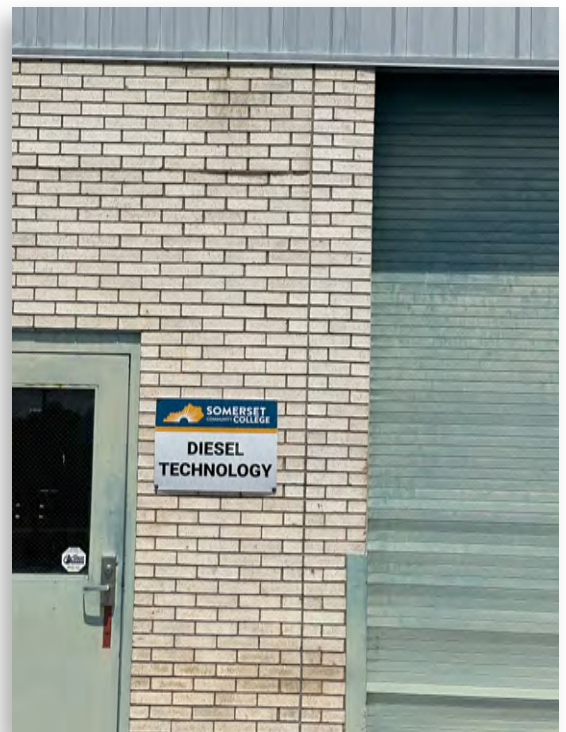
This photo of the parking lot side of the 1975 addition shows the expected expansion joint where the stresses in a brick wall are likely to cause damage to the bricks. However, this area again shows the issues with the relief angles 32" from the top of the brick (8 courses down) where the mortar has popped out of the joint. This issue with the relief angles is typical on all sides of the building.

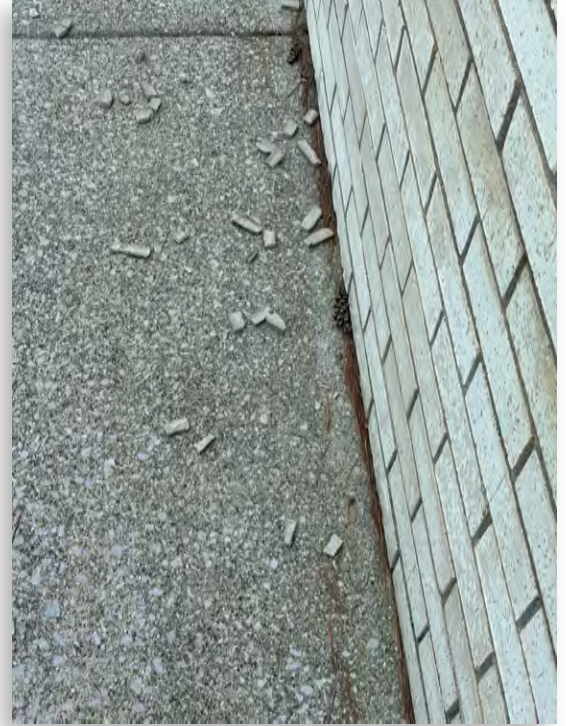
In the same area as the previous image, WPA found numerous fragments of mortar joints scattered on the sidewalk.

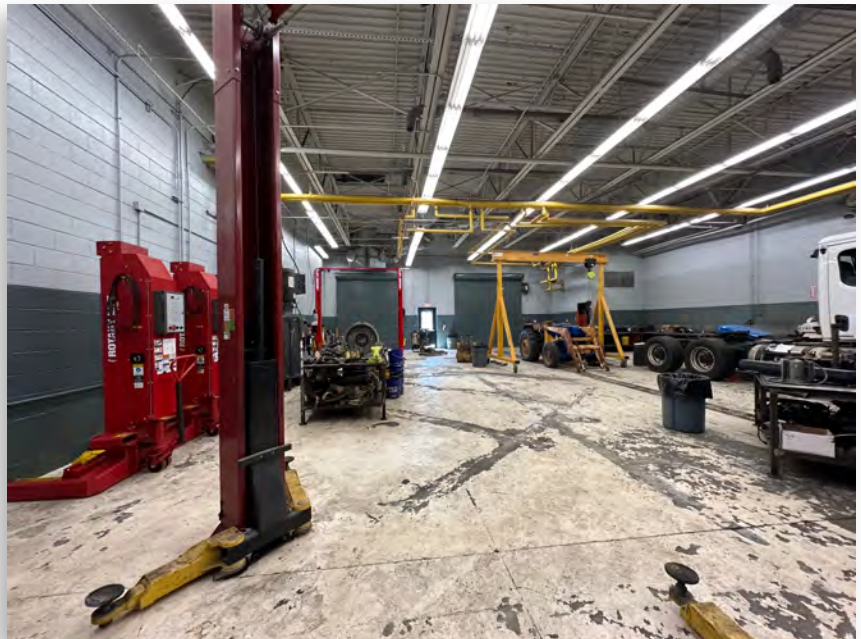
The Diesel Technology Lab, however did not appear to have any exhaust extraction systems. These shop spaces are provided with only heaters (fan-powered radiators) and are not conditioned spaces. The office spaces and classrooms have been equipped with a variety of A/C solutions from PTAC units to residential window units to provide cooling in these areas.

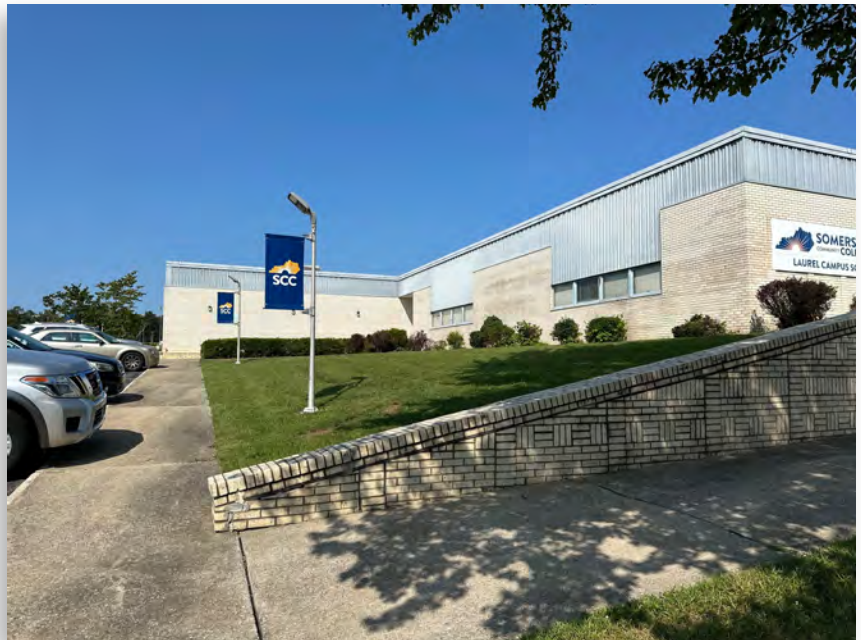
This retaining wall along the sidewalk leading to the main entrance is in disrepair. The wall has cracked and spalling bricks, damaged mortar joints and significant discoloration as it leads visitors up to the lobby.

WPa recommends repairs and improvements to all landscaping walls and fences around the building. This will add to the much-needed sense of place at the Laurel South Campus.
