October 31, 2024

RE: Southeast Kentucky Community and Technical College
Replacement of Whitesburg Bridge
2 Long Ave.
Whitesburg, KY 41858
B+K Project Number: 24310
AE job #: 000001

Pursuant to your request, Brown + Kubican, PSC performed an updated structural condition survey and opinion of probable cost estimate to further develop the scope of replacement for the pedestrian bridge at Southeast Kentucky Community and Technical College in Whitesburg, Kentucky. Our work included a new site observation of the pedway and review of available construction documents. We also reviewed the previous structural condition survey performed by Brown + Kubican, PSC in 2019. Preparation of construction documents (drawings and specifications) are not included in our current scope. Our observation was performed on October 28, 2024. All items discussed in the kick-off meeting on October 28, 2024 were also considered in the development of the scope of replacement.

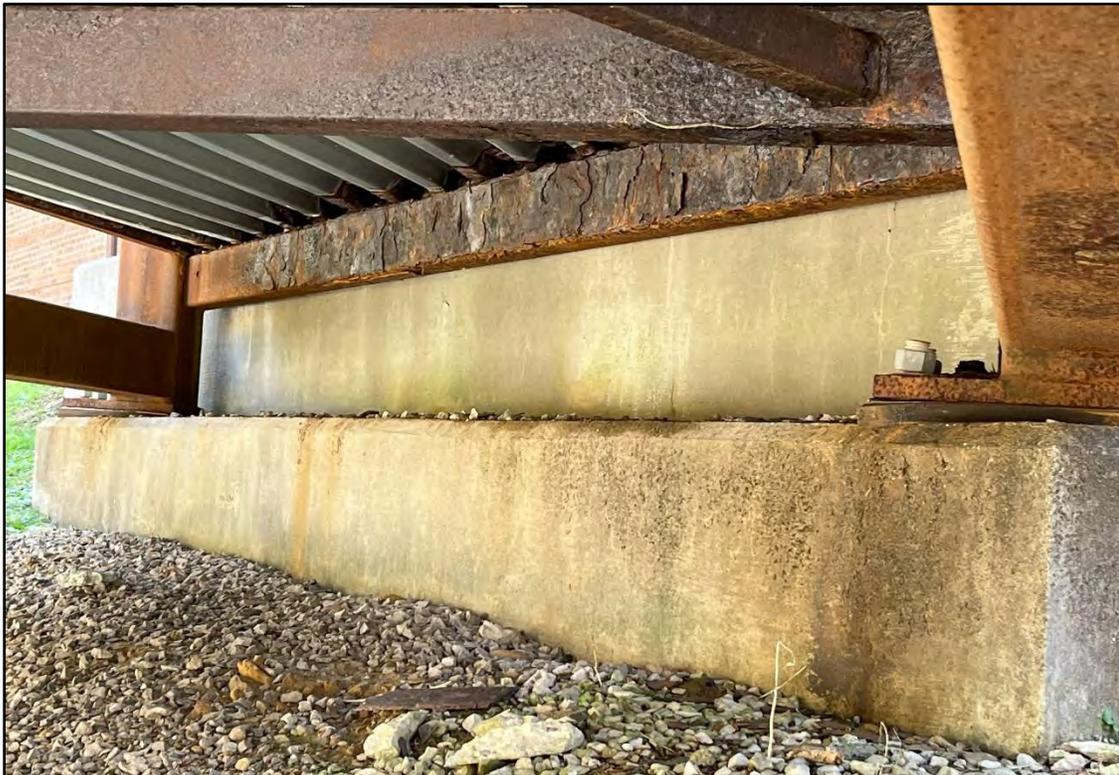
Image 2: Cross Member Above Abutment

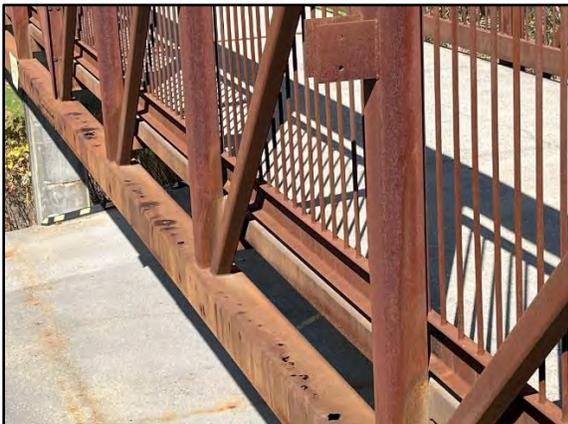
The truss bottom chords are in moderate to poor condition. The truss bottom chords have consistent mild delamination on the underside of the tube for the full length of the bridge on both chords. While no new measurements were taken, these chords appear to be in worse condition when compared to the photos in the 2019 report. The corrosion is especially severe near the splices.

We believe this is caused by the improper drainage of the walking surface above. The salt/water combination is draining onto the top of the steel bottom chords and causing the chords to rapidly deteriorate. Also, the bridge generally slopes to the west side of the deck, causing the water to drain to the West chord more than the East chord.

Image 6: West Bottom Chord Deterioration

1. Full superstructure replacement shall be performed. An in-depth load capacity check will be required at a later phase of the project to determine the structural viability of the piers and abutments, however for now, assume they will be retained.

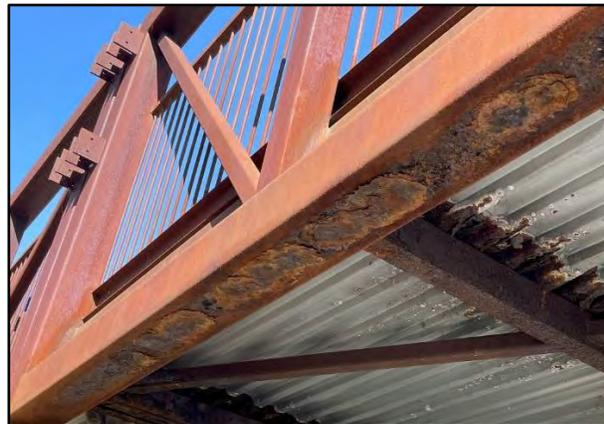
Image 7: Underside of Bottom Chord Delamination

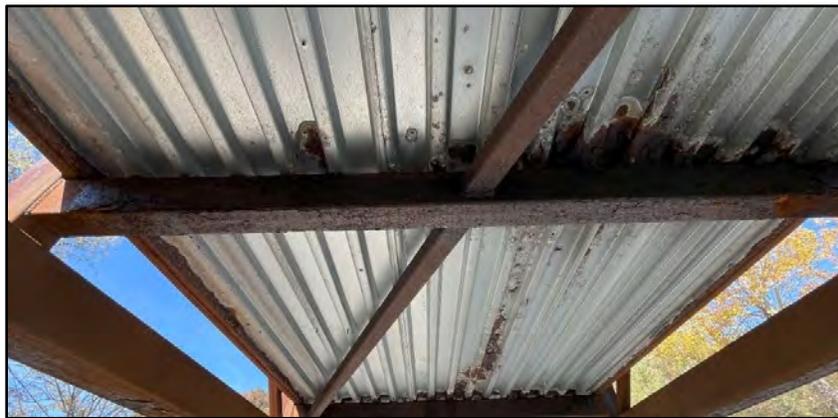
The cross members are consistently corroded and delaminating at both ends where they connect to the trusses. The bridge is spliced in two locations and has three end-bearing conditions. Each end bearing condition and splice is experiencing infiltration of water through the slab joint and significant corrosion of the cross members.

We believe this is due to the bridge improperly draining over the edge of the walking surface and corroding the end of the cross members. The lack of joint sealants at the splice and bearing locations is causing extra water to corrode the members below these locations.

Image 8: Cross Member Corrosion

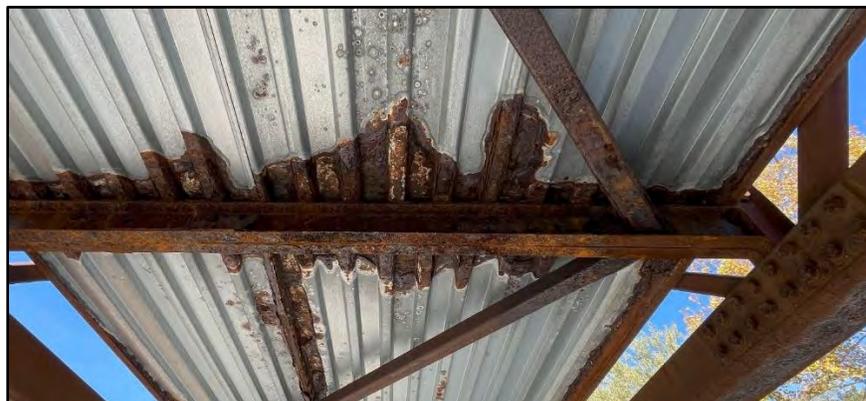
In general, the condition of the lateral braces below the deck are fair. The lateral brace members are corroding on all sides of the section at the ends connected to the cross members. Deterioration is currently localized to the surface of the members, deterioration has yet to greatly impact the welded connections.

We believe this is caused by the lack of joint sealant in the concrete slab on deck sawn joints. Water is infiltrating through the sawn joints and corroding the ends of the lateral braces.

Image 9: Lateral Bracing Corrosion

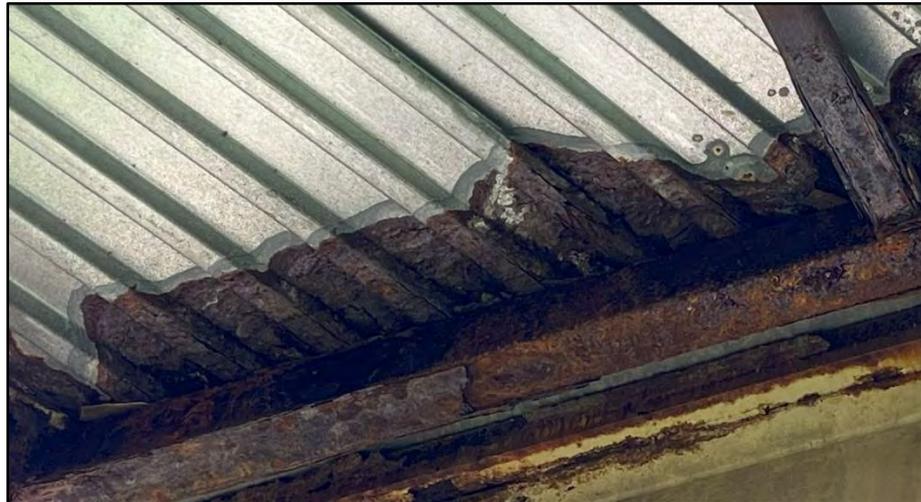
The concrete slab over the steel deck is in fair condition. All bearing locations of the galvanized steel deck are experiencing corrosion. Bearing locations include the ends, intermediate supports, and all edge conditions at the perimeter. All locations are experiencing moderate to severe corrosion with some localized areas experiencing full loss of the steel deck.

We believe the deck is corroding at these locations due to the interaction between the galvanized steel and weathering steel. Galvanized steel rapidly deteriorates when in contact with weathering steel. The weathering steel protective rust coating constantly corrodes the galvanized coating until it is gone, and the steel below deteriorates. Another cause is the lack of a traffic membrane allowing water to infiltrate through the sawn joints and corroding the steel deck.

Image 10: Weathering Steel/Galvanized Deck Interaction

This issue cannot be resolved without full replacement of the concrete slab on deck.

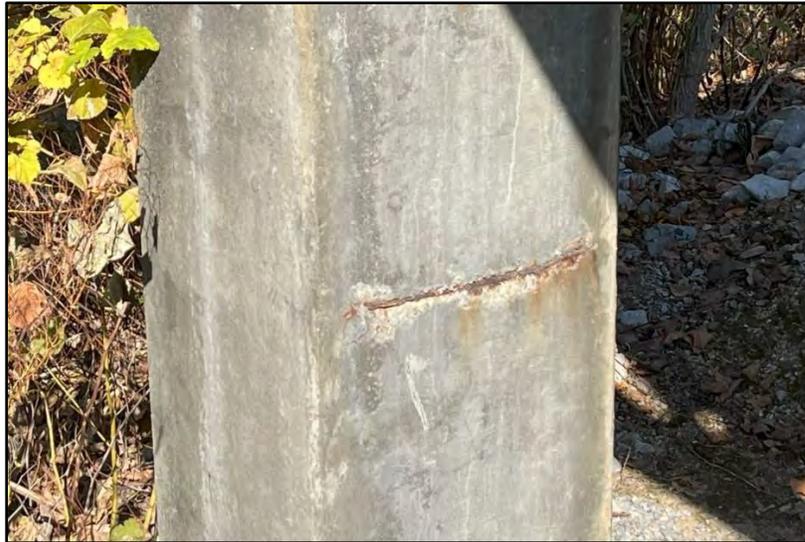
Overall, the concrete piers and abutments are in good condition. A few locations are experiencing spalling of the concrete and exposed corroded rebar. The south pier between spans 1 and 2 has an exposed section of reinforcement the full width of the Pier. Further exposure to the elements will result in additional loss of concrete and reinforcement section.

We believe this is a result of inadequate cover for the reinforcement, leading to accelerated corrosion of the reinforcement.

Image 11: Concrete Pier Spall

2. If the piers and abutments are found to be structurally sufficient to support the proposed load of the new superstructure, per load capacity calculations, the exposed rebar in the abutments and piers would be repaired. Sawcut around the perimeter of the exposed rebar, undercut concrete to $\frac{3}{4}$ " behind reinforcement, blast clean, prime, and apply repair mortar.

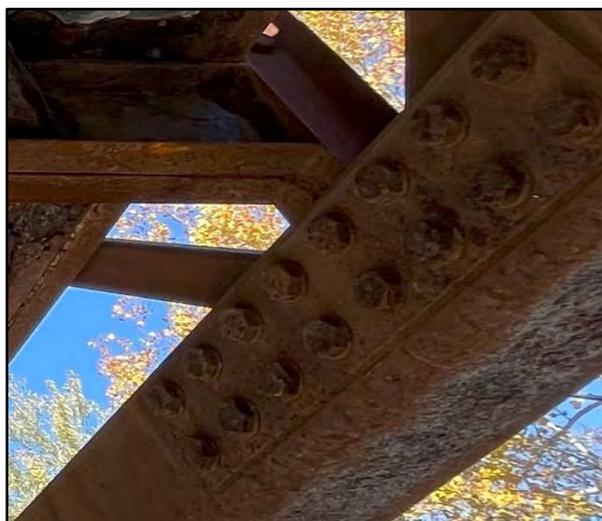
The condition of the bolts at the chord splices were not able to be inspected. Each splice has external cover plates with bolts that thread to an interior nut. Some surface rust was seen at the interior of the chord splice. We are concerned that the bolts are experiencing section loss and severe loss of bearing against the chord walls.

We believe this is caused by the lack of weep holes in the bottom chord, leading to the bottom chords collecting water.

Image 12: Bottom Chord Splice Corrosion

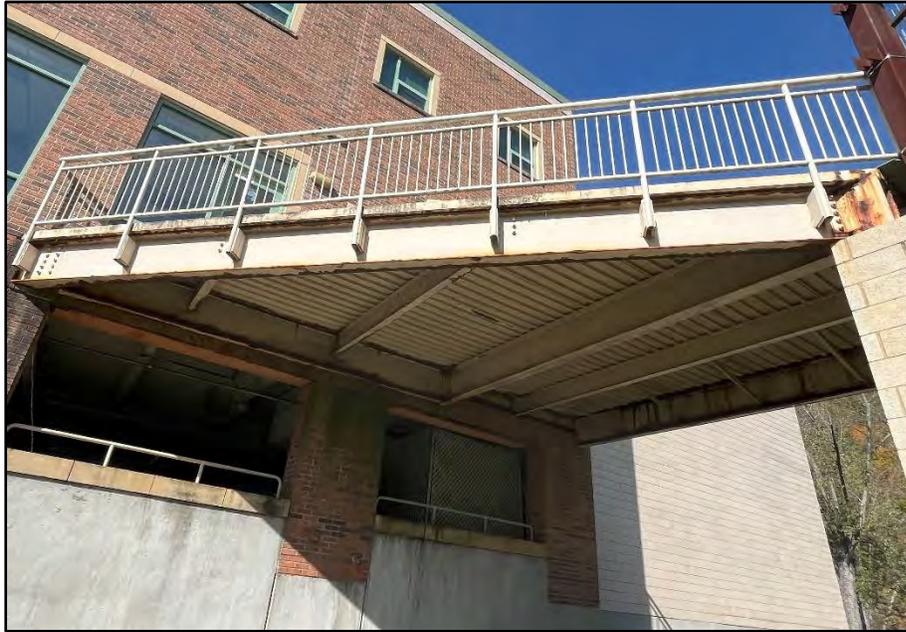
Image 13: North Raised Landing

The condition of the landing has deteriorated since the observations made in 2019. The steel beams are showing moderate section loss due to corrosion of the top and bottom flanges around the perimeter of the landing. Some localized corrosion was observed at the underside of the deck and at bearing conditions resulting in approximate 90% section loss of the steel deck. The edge angle is experiencing surface rust where it is in contact with the beam top flange.

Due to the acceleration of corrosion determined by comparing the photos from 2019 to our current photos, and the compromised state of the masonry-wrapped columns from the flood of 2022, it is recommended to remove and replace the landing slab, including all steel support beams and both masonry-wrapped steel columns. The lintels beneath the landing in the parking garage wall, should also be replaced (including the soldier bricks between the lintels and landing support beams) due to their accelerated corrosion. The slab on deck should be replaced with a formed slab and be sealed to prevent further water infiltration.

4. Replace the raised landing slab, including all steel supporting members and the two masonry-wrapped columns. Also, replace the two lintels beneath the landing (above the two openings for the parking garage), including the soldier bricks between the lintels and landing support beams.

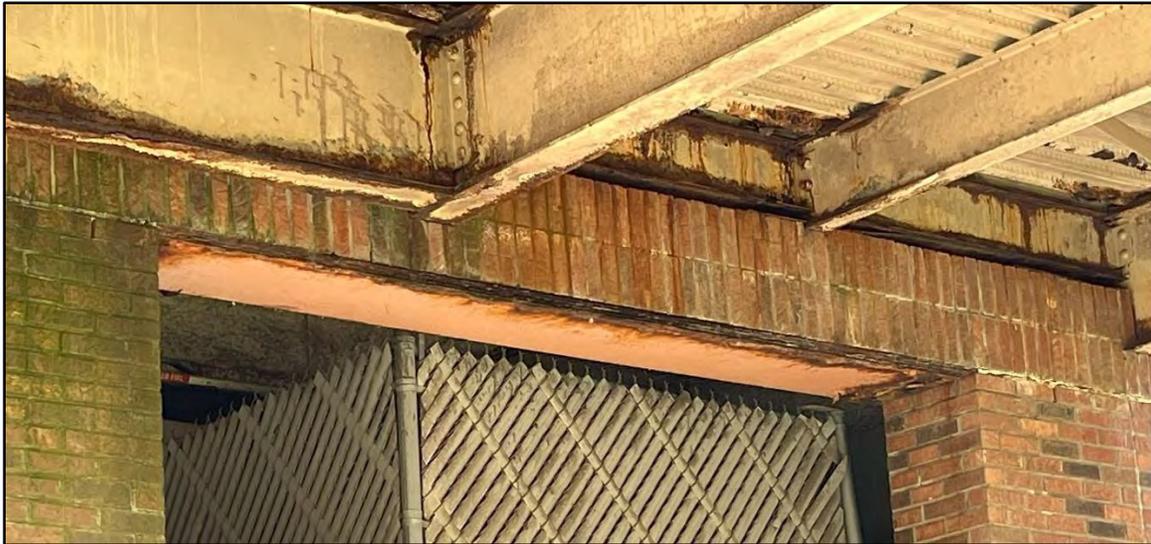
We believe the corrosion of the underside of the raised landing is due to no galvanizing used on the steel, no special detailing for exterior exposure, no sealant on the concrete slab, and concealed/trapped structure against the building with no weathering protection.

Image 14: North Landing Underside Corrosion

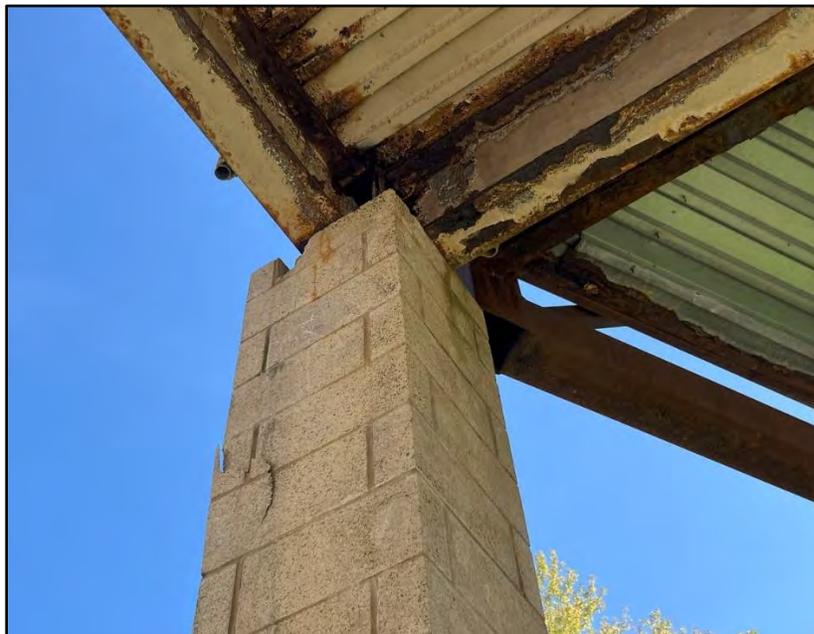
Also, as mentioned in the kick-off meeting, the 2022 flood crest elevation was within feet under the bridge and appears to have chipped off the masonry wrapping on the east column, exposing the steel column to the elements. Due to an exposure of over 2 years and the state of the remainder of the landing, we believe it is unreasonable to repair this column.

Image 15: Chipping of Masonry from Flooding

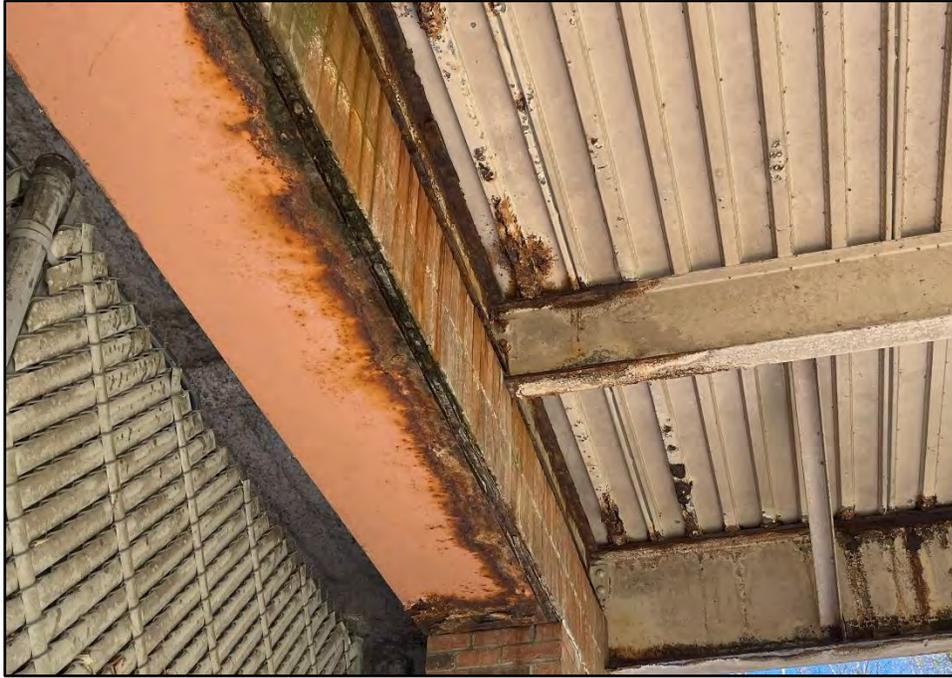
Image 16: Lintel Corrosion Under Raised Landing
