Fix bad patch cables at City Hall

Report updating Management/Board on the issue By Aristo Networks LLC

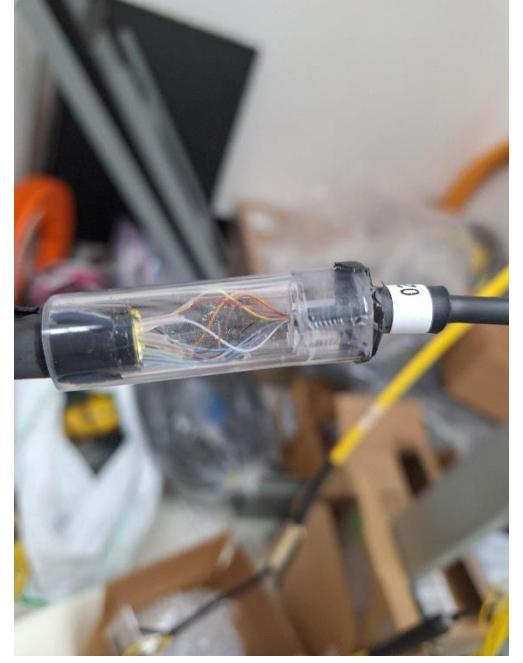
Aristo Networks originally went through a couple of the cables and documented the loss at both 1310 and 1550 frequencies for each fiber. Next Aristo Networks took one of the cables and attempted to

Testing Loss at City Hall		
	Cable	ID	1310 Reference	1590 Original	1590 Final	
		22		.13		
STATISTICS IN CONTRACTOR		23	*	,23		
		24		,75	110	
		25		, 85	:40	
And the second		26		156	,07	
	Contraction of the second	27		149	,24	
		28		182	137	
		29		,58	,44	
		30	Same and	,62	,48	
		31		5,69	2,43	
-		32	BOD BOD	99	,20	
		33		4.16	,60

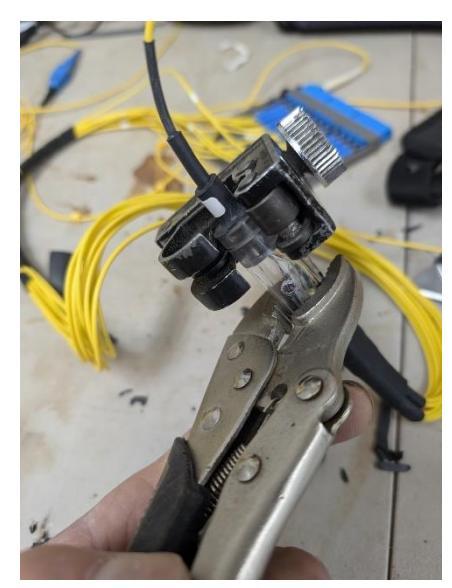
different sections of the cable. It was identified that applying pressure / bending the fiber near or at the splice tube generated changes in loss. Next, Aristo Networks peeled back the protective shrink rubber at the splice tube.

C:\Data\Qlife\Reports\Generic Reports\Fix Patch Cables At City Hall.Docx John Amery Page 2 of 3 9/23/2024 A microbend of the fiber was visible inside the splice tube. Next Aristo Networks used a pipe cutter

and made a circular cut around the splice tube which allowed the fibers to extend out thus removing the microbends of the worst offending splices. And then lastly, Aristo Networks secured the previously opened splice tube by re-applying heat shrink over the splice tube. While not every splice could be fixed using this method, nearly all
