# SOUTHEAST KENTUCKY COMMUNITY AND TECHNICAL COLLEGE

Whitesburg Campus – Bridge Repairs  
470-C9DX STRUCT

RE: Southeast Kentucky Community and Technical College  
Whitesburg Campus – Bridge Repairs  
2 Long Ave.  
Whitesburg, KY 41858  
B+K Project Number: 19204  
KY job #: 470 – C9DX STRUCT

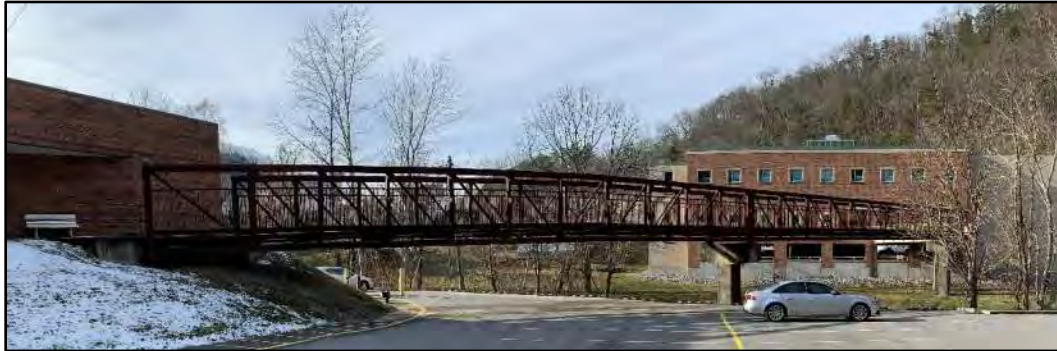
The existing pedestrian bridge is a two-span steel pratt truss between the Mason Academic Building and the Hogg Allied Health Center. The truss has HSS8x8 top and bottom chords, HSS5x5 verticals and HSS3x3 diagonals. Each truss is connected together with HSS6x4 cross members and HSS3x3 lateral bracing below the concrete slab on deck to provide lateral buckling stability. The bridge has an open top with tabs welded to the vertical members for the attachment of a roof. The existing drawings call for the roof to be an alternate; no roof was installed at the time of our inspection. All steel tube members are welded together all around. Steel guardrails are constructed using channels and rounds steel rods for the entire length of the pedway. All steel has a weathering finish. Weathering steel is installed as “raw” steel and allowed to rust. The rust performs a protective coating to the elements. The bridge is spliced with bolted splice plates at two locations, the mid span of each span.

*Image 3: Bridge East Elevation*

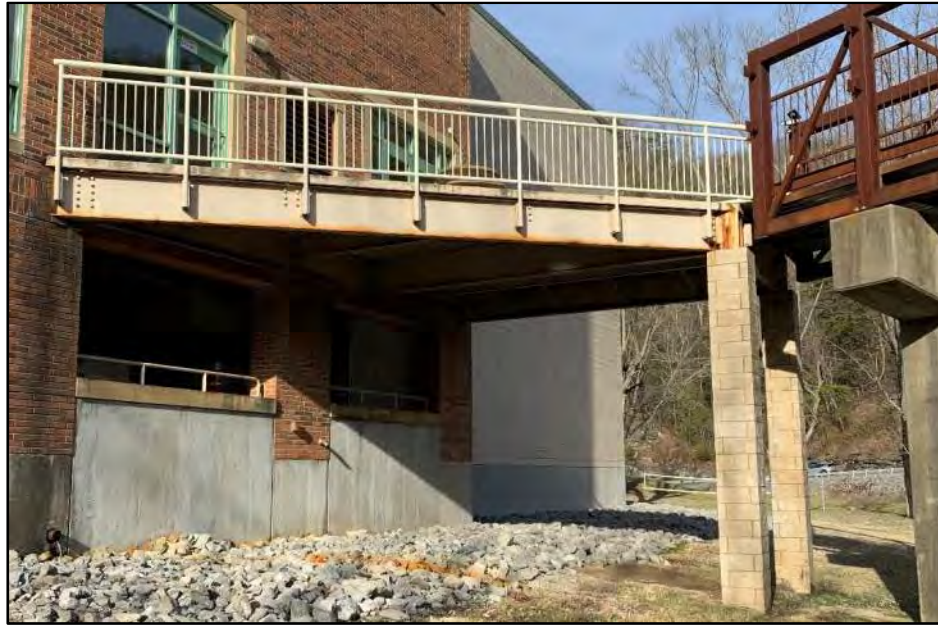
The raised landing at the North end of the bridge is constructed of a concrete walking surface that appears to be unsealed. The walking surface is constructed with a 2 ½" concrete slab over 1 ½" composite painted metal deck (4" total thickness) spanning between wide flange steel beams. The steel beams are supported by steel columns wrapped in masonry piers and the building. A steel handrail is attached to the edge angle around the perimeter of the raised landing. The foundation system of the landing is concrete drilled piers. All steel, including the underside of the steel deck, is painted.

*Image 5: Raised Landing*
