Final Report for

KCTCS - LAUREL SOUTH CAMPUS FEASIBILITY STUDY SOMERSET COMMUNITY COLLEGE

Laurel South Feasibility Study

1 September 2023

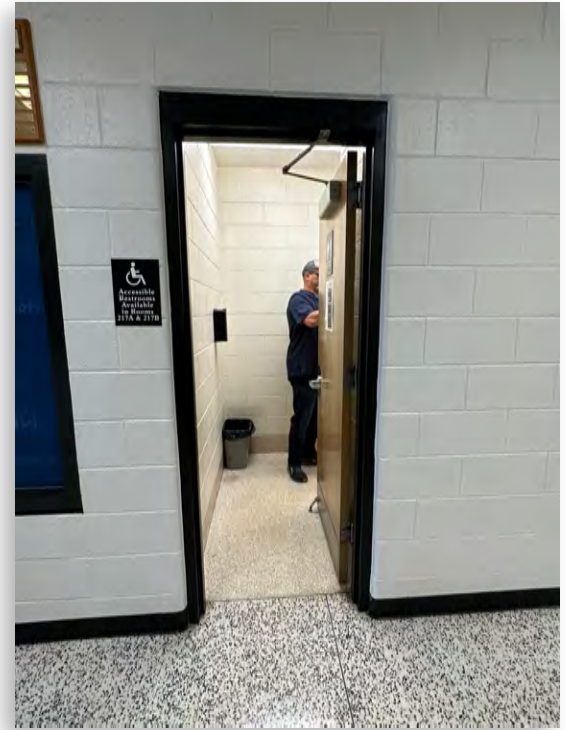
The sign to the left of the door explains that “accessible restrooms are available in Rooms 217A and 217B” at the other end of the building. The door here is 32” wide and leads into a series of switch backs to enter this unisex restroom. The other restroom that was originally paired with it has been converted into a lactation room to the right down the corridor. This building, designed and constructed long before the Americans with Disabilities Act was passed into law has very few accessible features. The fact that it was built with CMU walls and terrazzo floors makes changes to the restrooms very difficult. Moreover, by the current Kentucky Plumbing Code, the building should have 13 water closets for females in the design. The existing count falls far below this number. (1:25 water closets to females and 1:50 water closets to males).

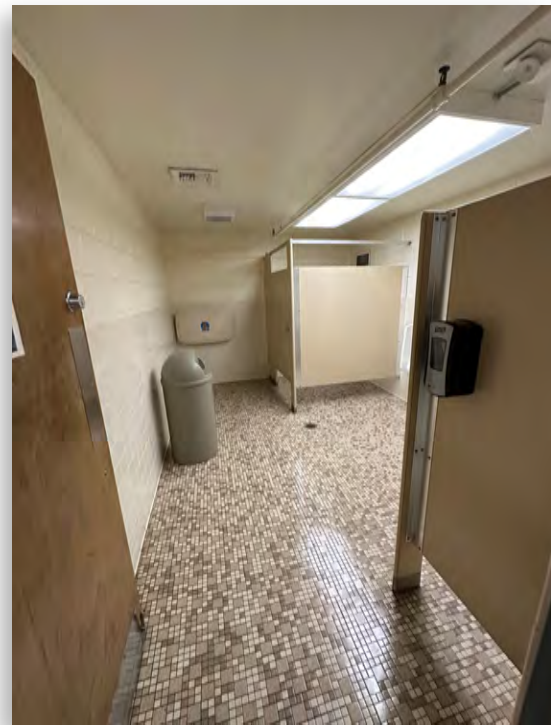
The accessible restrooms at 217A and 217B are actually in 217B and 217C according to the room plan provided to WPA. However, since there is no room signage outside the restrooms, it hardly matters. This photo of the men's room shows that it meets the bare minimum required for accessibility: One toilet, two urinals and two sinks. The lighting and finishes are well cared for but minimal.

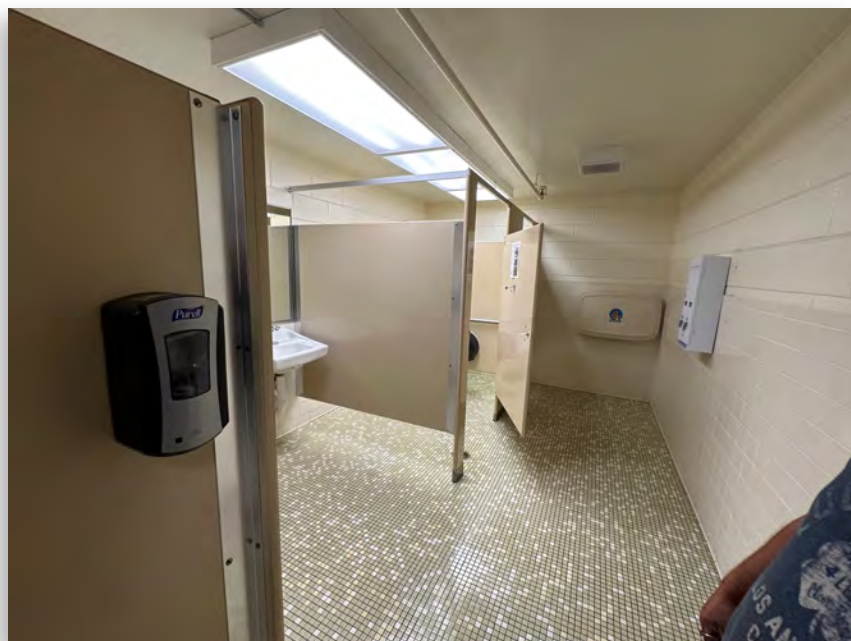
The women's room next door is similar in size and in its lack of lighting and minimal approach to finishes.

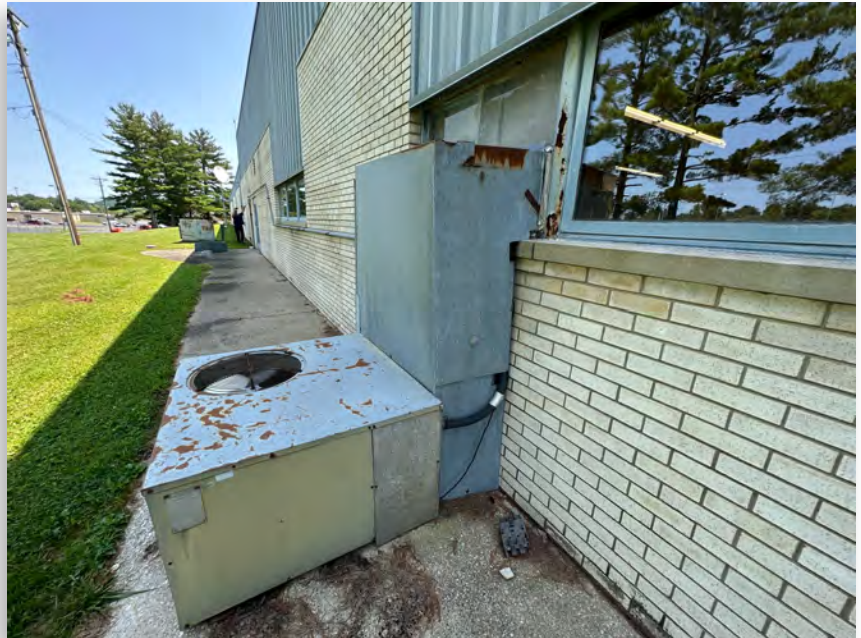
The photo at right is a good starting place for a discussion about the mechanical systems in the Laurel South building. This mechanical unit is serving the former masonry shop which has been converted into the electrical shop. The HVAC needs changed and this is how those needs were met.

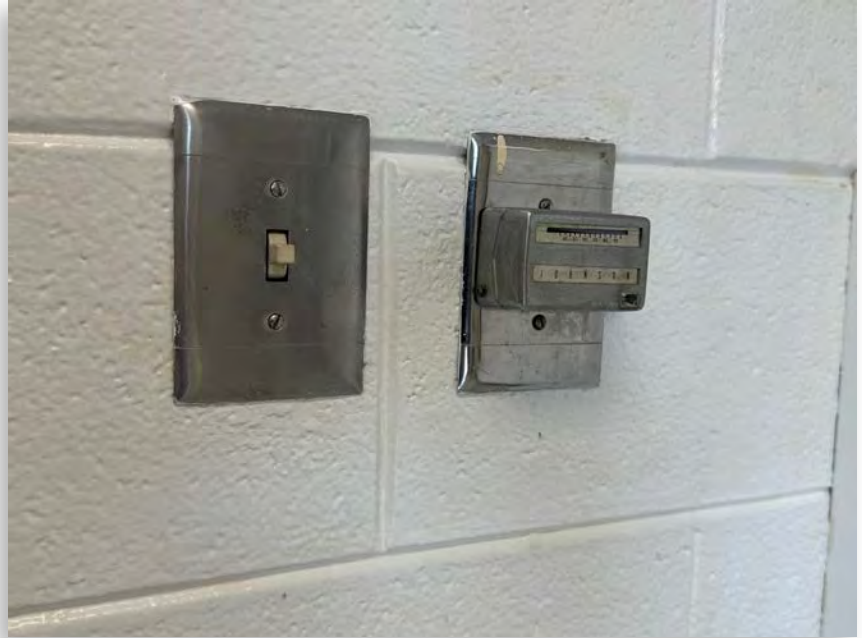
Lighting and HVAC controls are outdated and should be upgraded with the new mechanical units.

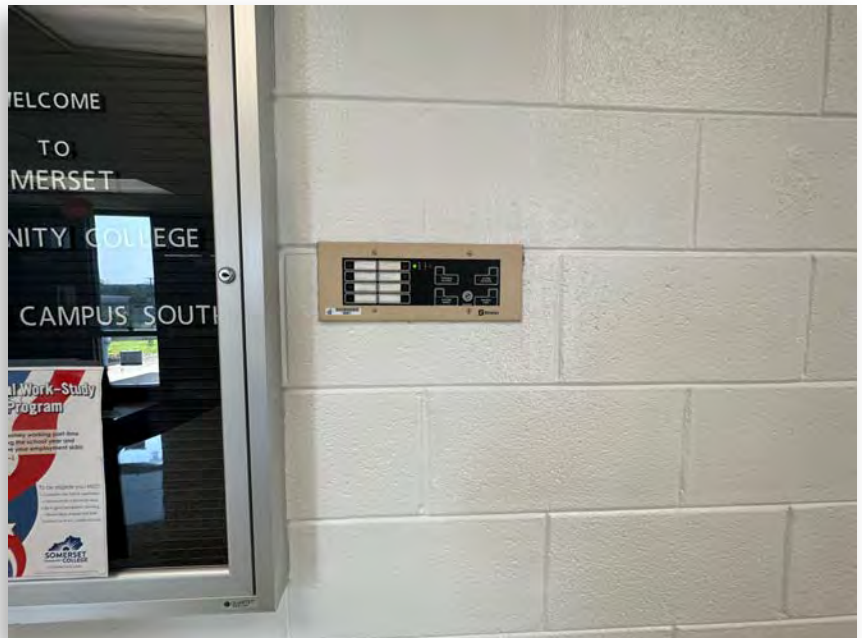
There are a variety of panels and devices associated with the fire alarm. Many of these are outdated and should be upgraded if no longer serviceable.

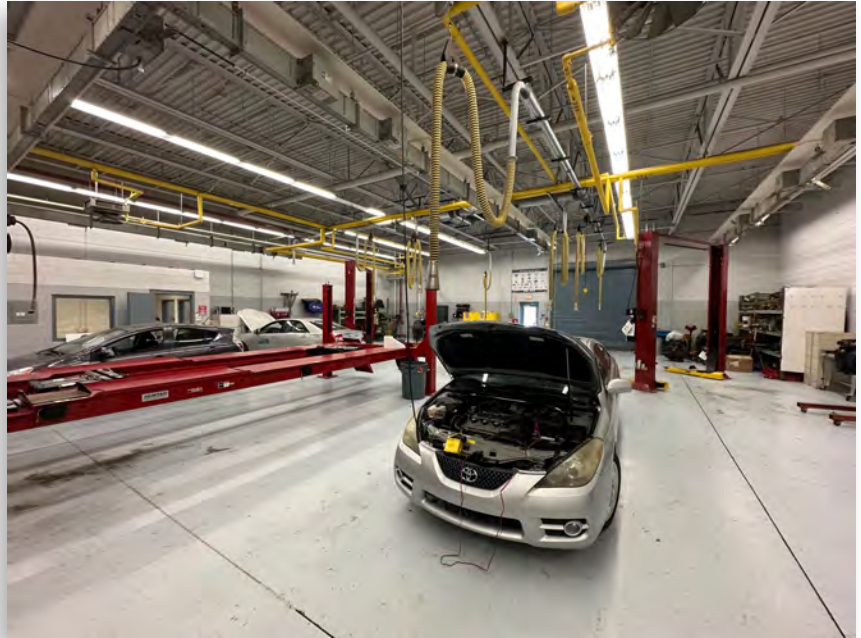
The Automotive Lab has a number of nozzles attached to an exhaust extraction system. These systems are crucial when working on a running vehicle indoors. WPA was unable to find about the attachment protocols for the nozzles in place. The ones seen here did not appear to have clips to hold them in place on horizontal exhaust systems like those on the car shown.

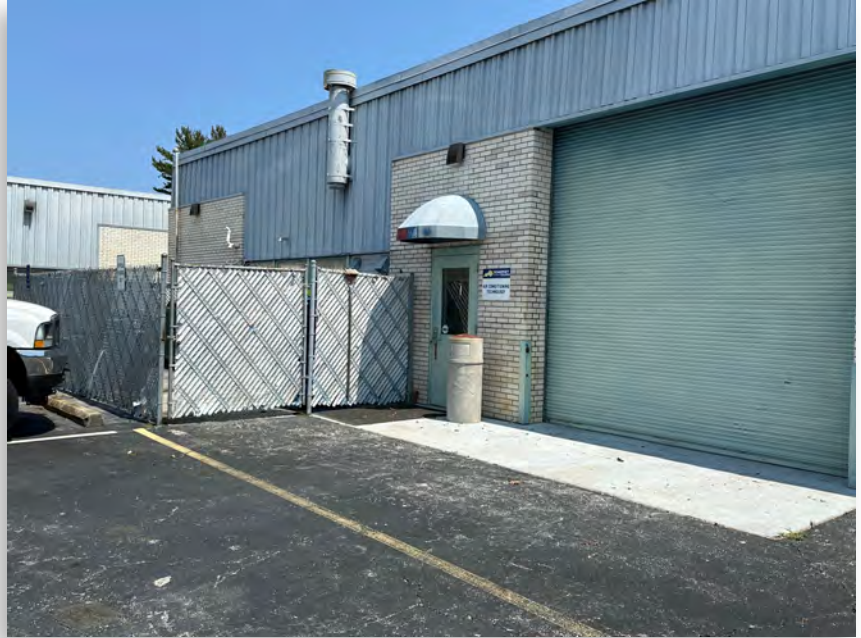
This fenced area is outside the HVAC shop and houses a collection of condensing units associated with the shop. Renovation of the building should address areas like this outside as well.
