October 31, 2024

RE: Southeast Kentucky Community and Technical College
Replacement of Whitesburg Bridge
2 Long Ave.
Whitesburg, KY 41858
B+K Project Number: 24310
AE job #: 000001

Pursuant to your request, Brown + Kubican, PSC performed an updated structural condition survey and opinion of probable cost estimate to further develop the scope of replacement for the pedestrian bridge at Southeast Kentucky Community and Technical College in Whitesburg, Kentucky. Our work included a new site observation of the pedway and review of available construction documents. We also reviewed the previous structural condition survey performed by Brown + Kubican, PSC in 2019. Preparation of construction documents (drawings and specifications) are not included in our current scope. Our observation was performed on October 28, 2024. All items discussed in the kick-off meeting on October 28, 2024 were also considered in the development of the scope of replacement.

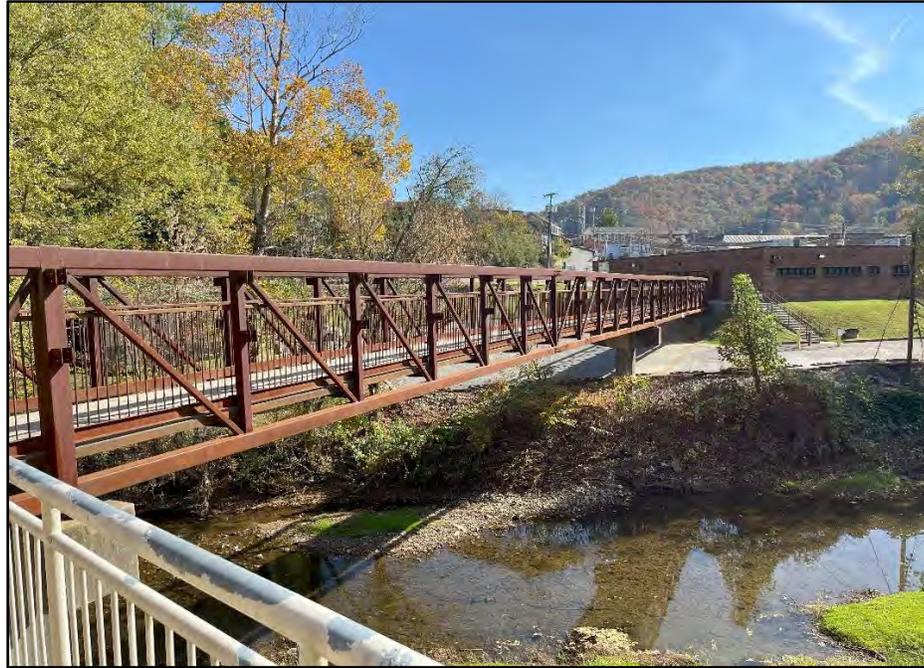
Image 3: Bridge West Elevation

The existing pedestrian bridge is a two-span steel pratt truss between the Mason Academic Building and the Hogg Allied Health Center. The truss has HSS8x8 top and bottom chords, HSS5x5 verticals and HSS3x3 diagonals. Each truss is connected together with HSS6x4 cross members and HSS3x3 lateral bracing below the concrete slab on deck to provide lateral buckling stability. The bridge has an open top with tabs welded to the vertical members for the attachment of a roof. The existing drawings call for the roof to be an alternate; no roof was installed at the time of our inspection. All steel tube members are welded together all around. Steel guardrails are constructed using channels and rounds steel rods for the entire length of the pedway. All steel has a weathering finish. Weathering steel is installed as "raw" steel and allowed to rust. The rust performs a

protective coating to the elements. The bridge is spliced with bolted splice plates at two locations, the mid span of each span.

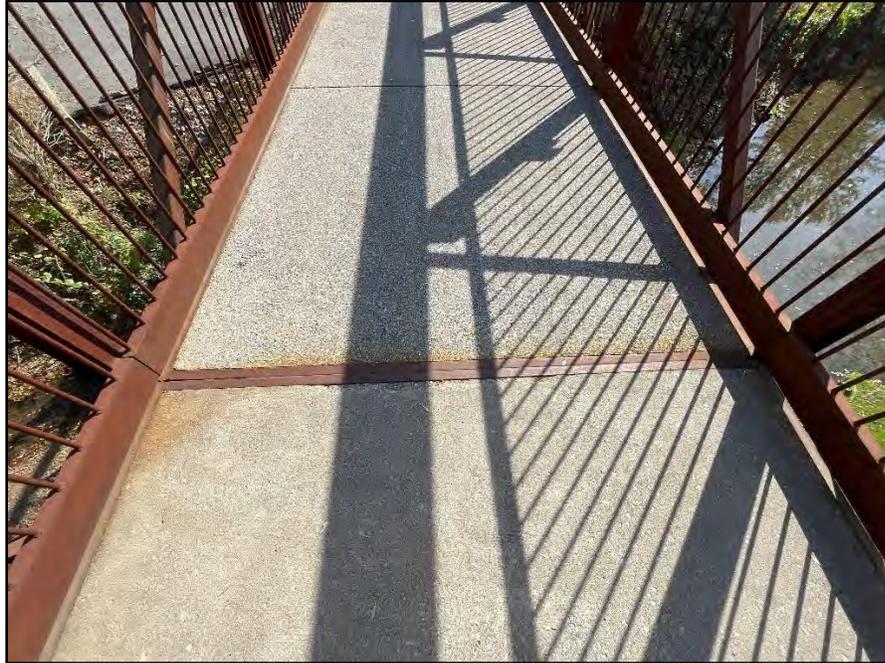
Image 4: Bridge Walking Surface

The walking surface is exposed concrete with no apparent sealer or traffic membrane. The concrete surface has a broom finish with sawn construction joints at $\sim 7'-6"$ on center with no sealer in the joints. The walking surface is constructed with $2\frac{1}{2}"$ concrete over non-composite $1\frac{1}{2}"$ galvanized metal deck (4" total thickness). The bridge spans between concrete abutments and piers with no apparent sealer applied to their surface. The Southeast span ($\sim 80'-0"$) is over a parking lot and the Northwest span ($\sim 100'-0"$) is over the North Fork Kentucky River. The height to the underside of the bridge ranges from $\sim 7'-6"$ at the Southeast span and $\sim 17'-9"$ at the Northwest span. Photographs of the bridge and its components were taken, some of which are included herein.

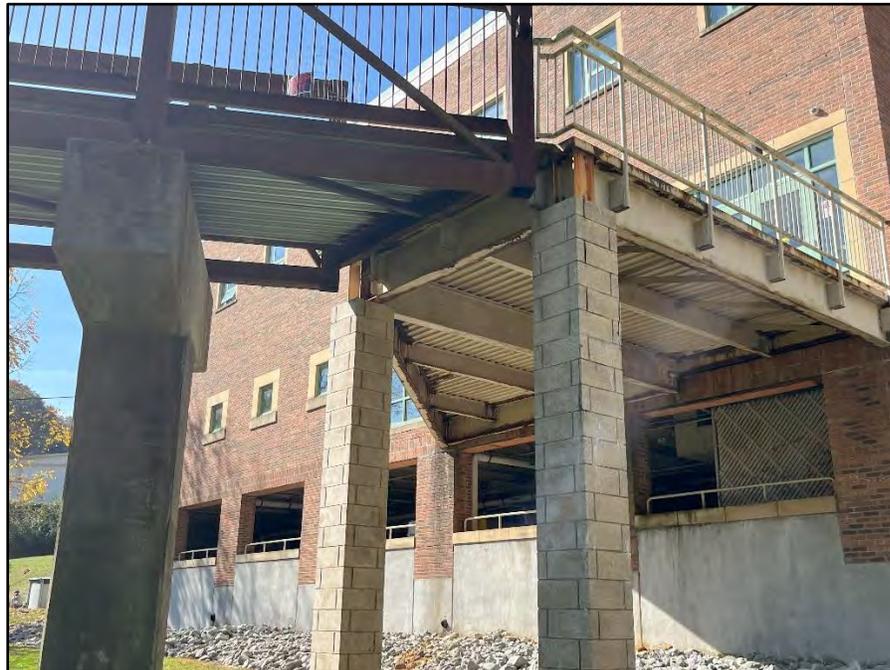
Image 5: Raised Landing

The raised landing at the North end of the bridge is constructed of a concrete walking surface that appears to be unsealed. The walking surface is constructed with a $2\frac{1}{2}"$ concrete slab over $1\frac{1}{2}"$ composite painted metal deck (4" total thickness) spanning between wide flange steel beams. The steel beams are supported by steel columns wrapped in masonry piers and the building. A steel handrail is attached to the edge angle around the perimeter of the raised landing. The foundation system of the landing is concrete drilled piers. All steel, including the underside of the steel deck, is painted.
