Re: Submittal of 2020 Annual Report for City of Princeton Restoration Projects
Permit #MN0024538
WSB Project No. R-013992-000

I. INTRODUCTION

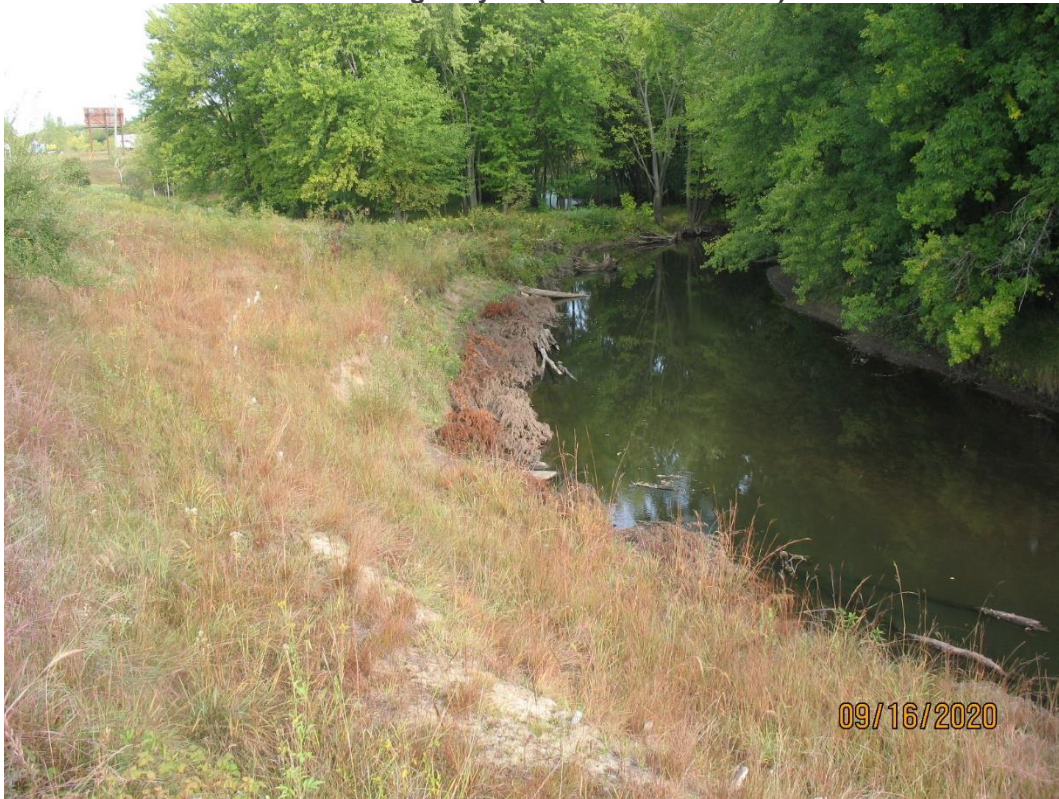
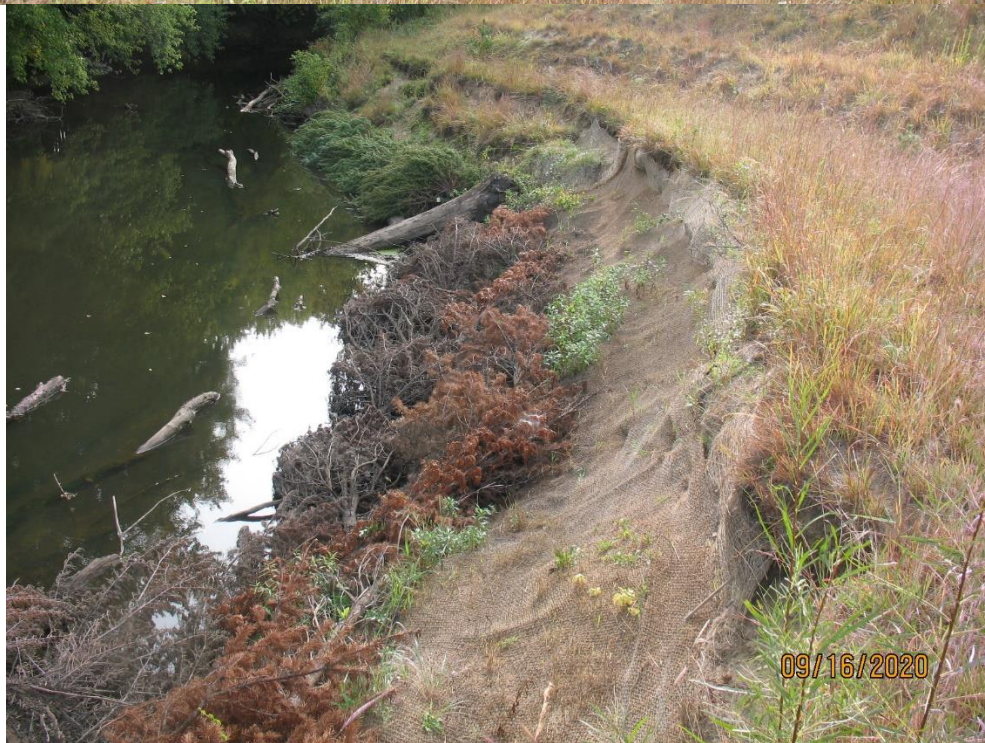
Site 1 – Highway 95 (2012 Construction)

- Some minor sloughing and undercutting
- A small hole observed in the bench. The hole was noted in 2019 but does not appear to have grown in 2020.

- Install additional blanket, seed, and approximately 180 linear feet of revetments
- Apply fertilizer

- Additional seeding as needed to fill in bare spots.
- Monthly inspection of the site to document bank erosion at the upstream end and determine if additional repair work is required

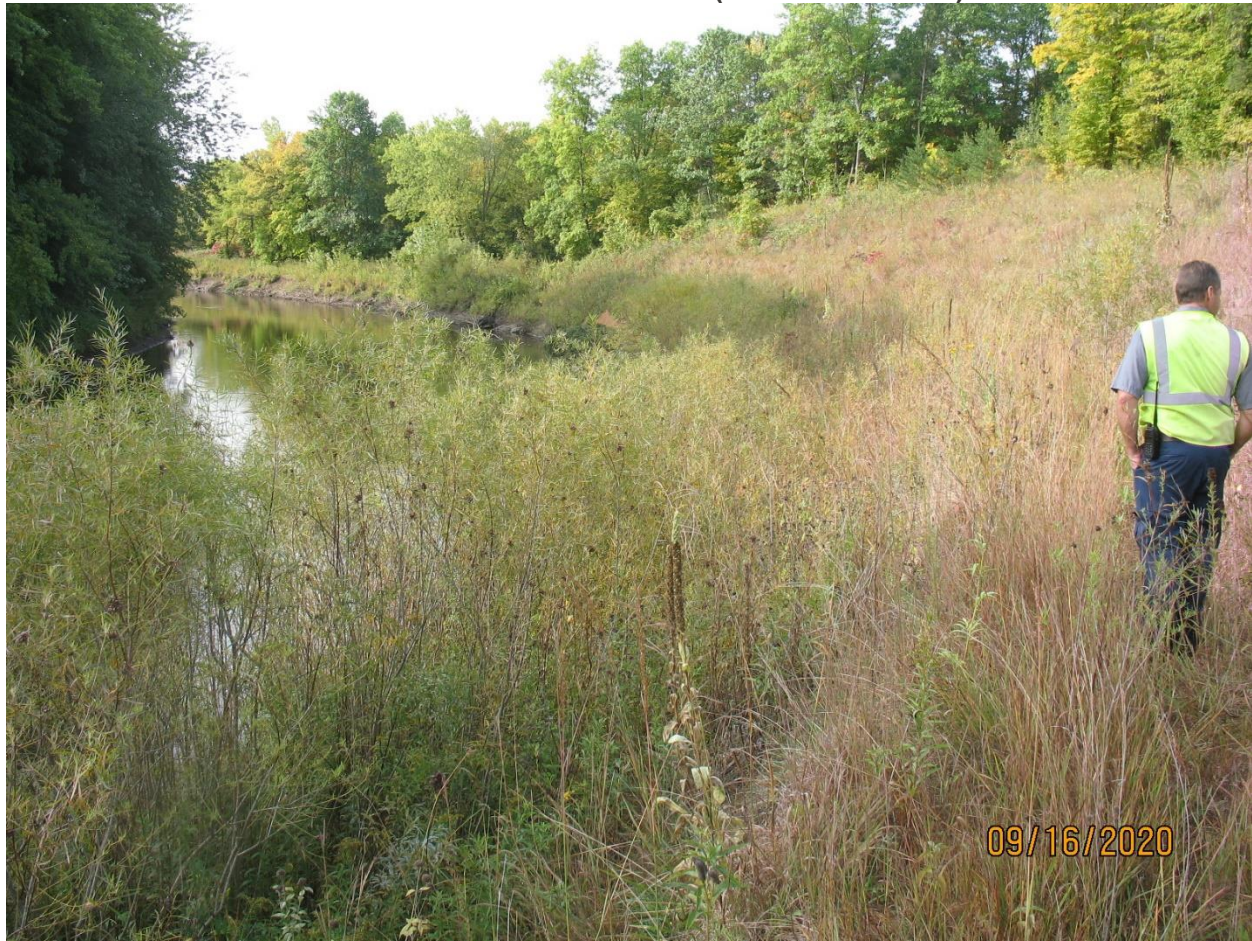
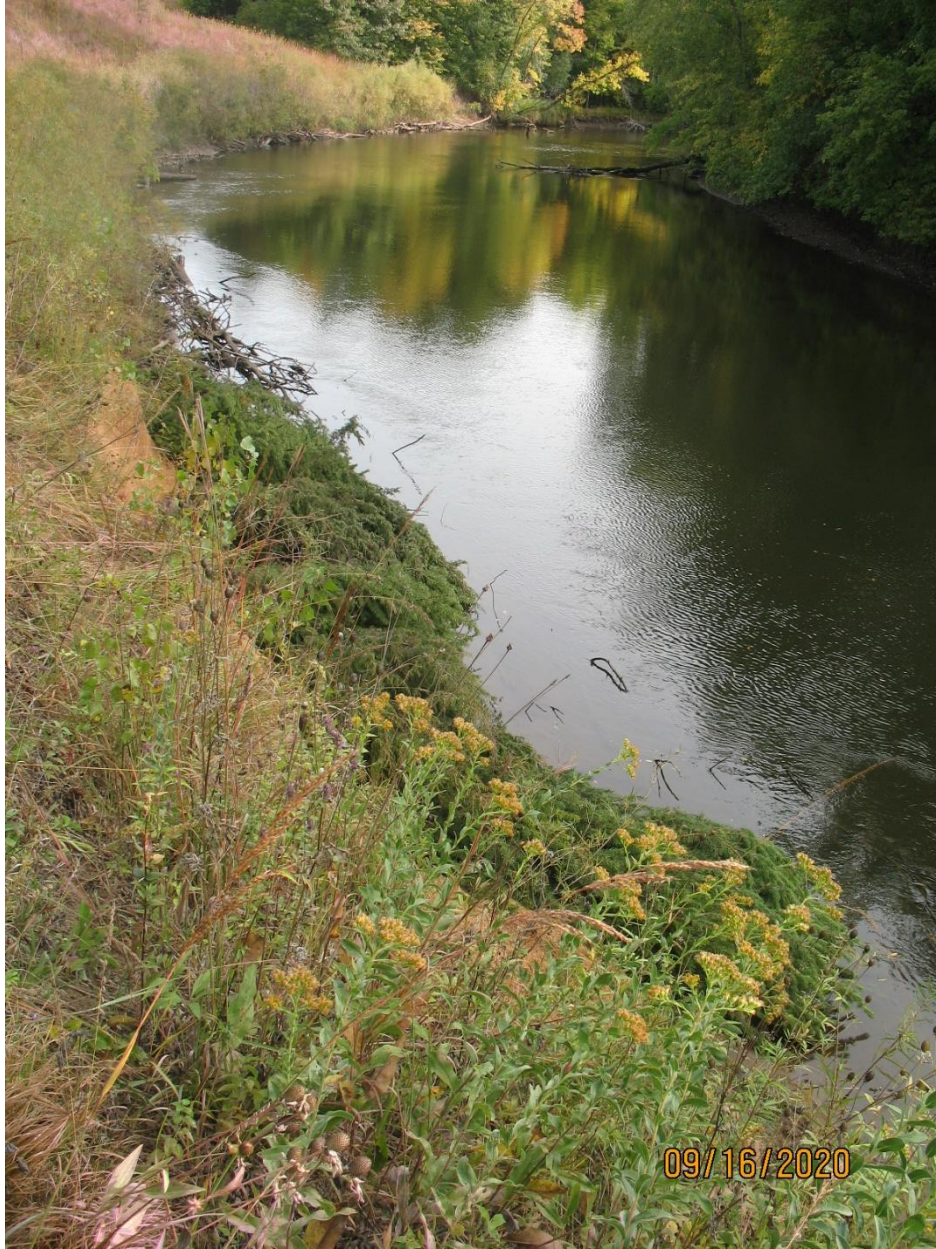
Site 2 – Princeton Middle School (2012 Construction)

- Bare areas which lack vegetative cover.
- Minor erosion occurring at the upstream end of the site.

- Install additional blanket, seed, and approximately 100 linear feet of revetments
- Apply fertilizer

- Additional seeding as needed to fill in bare spots.
- Monthly inspection of the site to document bank erosion at the upstream end and determine if additional repair work is required.

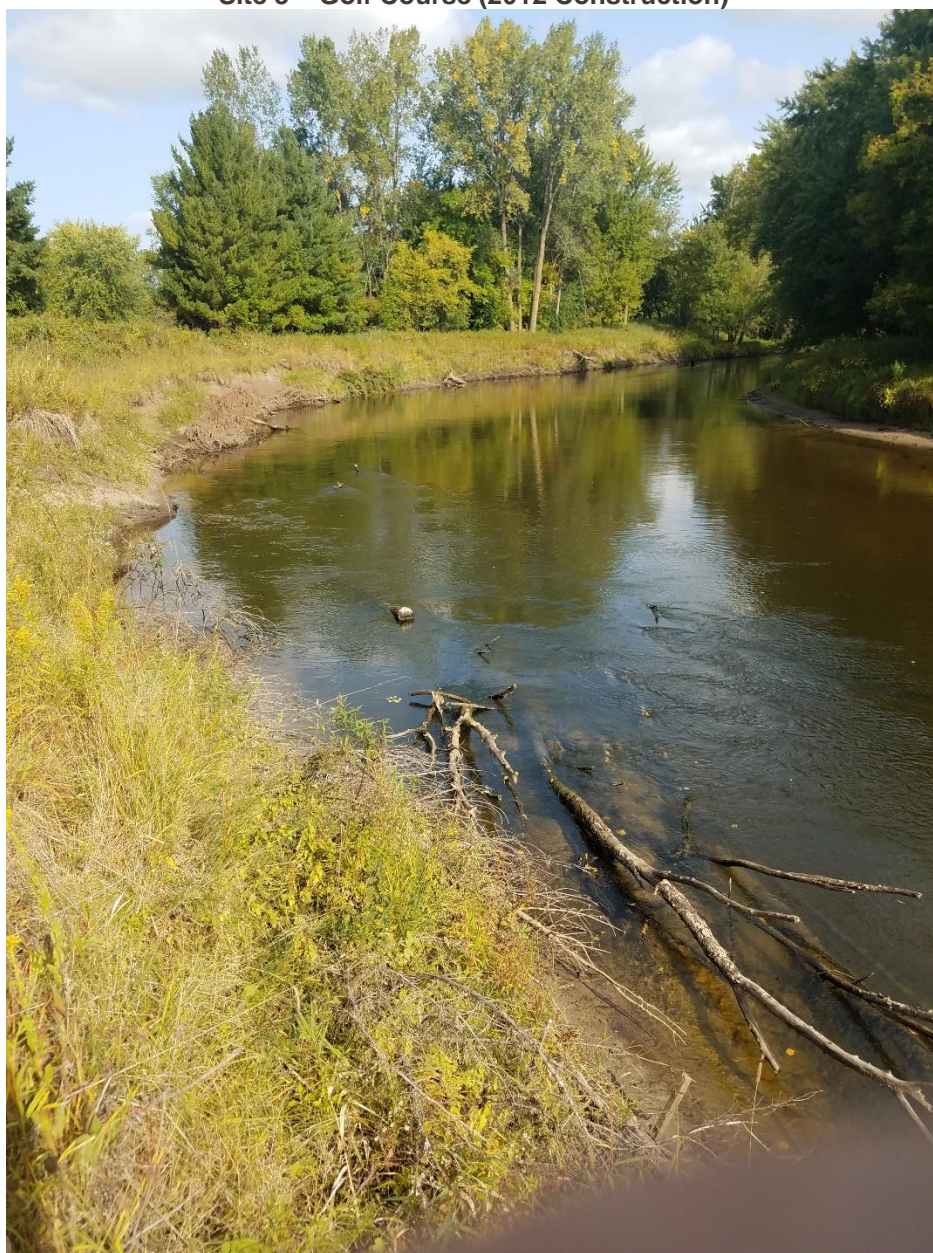
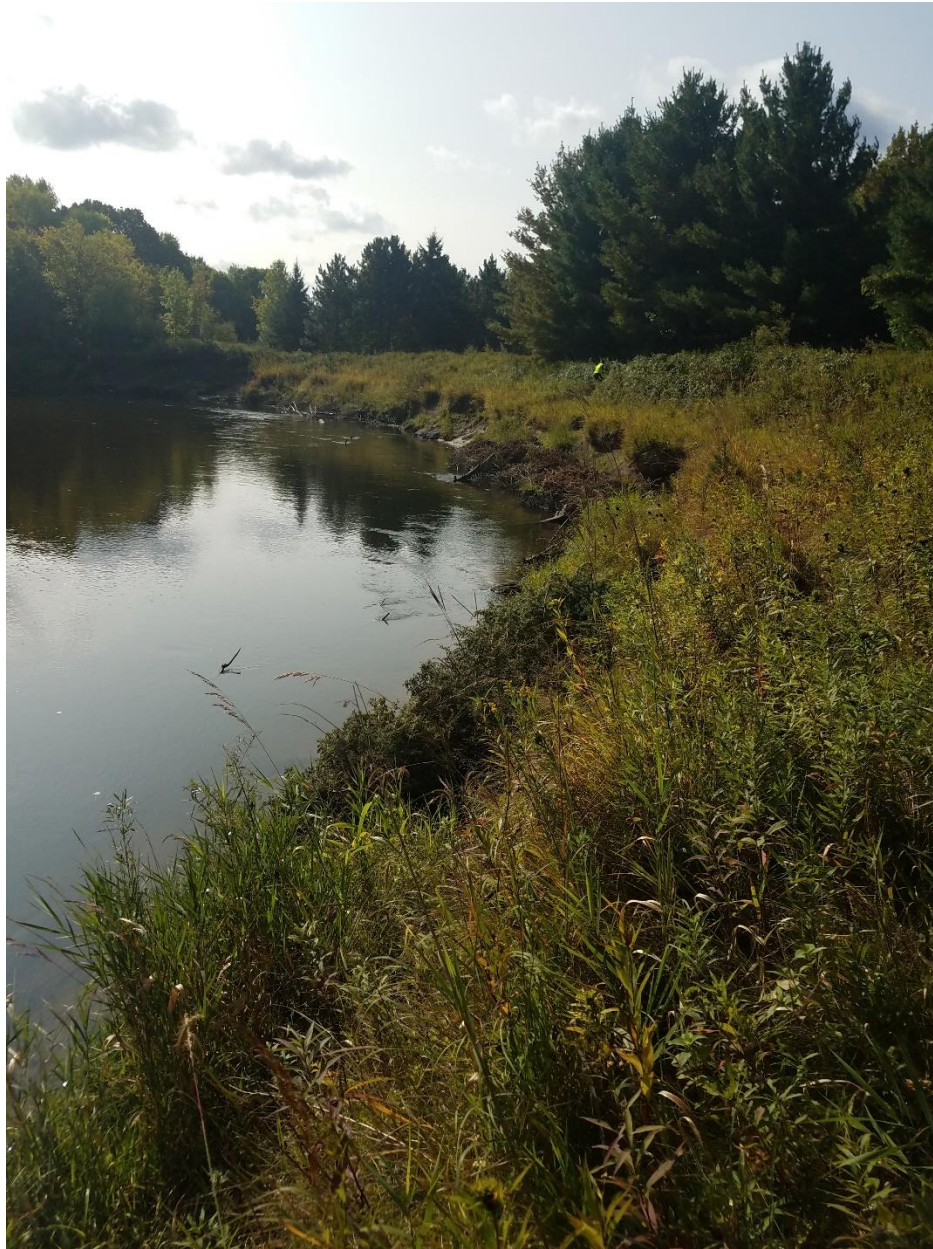
Site 3 – Golf Course (2012 Construction)

- Minor bank sloughing
- Erosion occurring downstream of the project site.

- Install additional blanket, seed, and approximately 135 linear feet of revetments
- Apply fertilizer

- Additional seeding as needed to fill in bare spots.
- Monthly inspection of the site to document bank erosion and sloughing areas and determine if additional repair work is required.

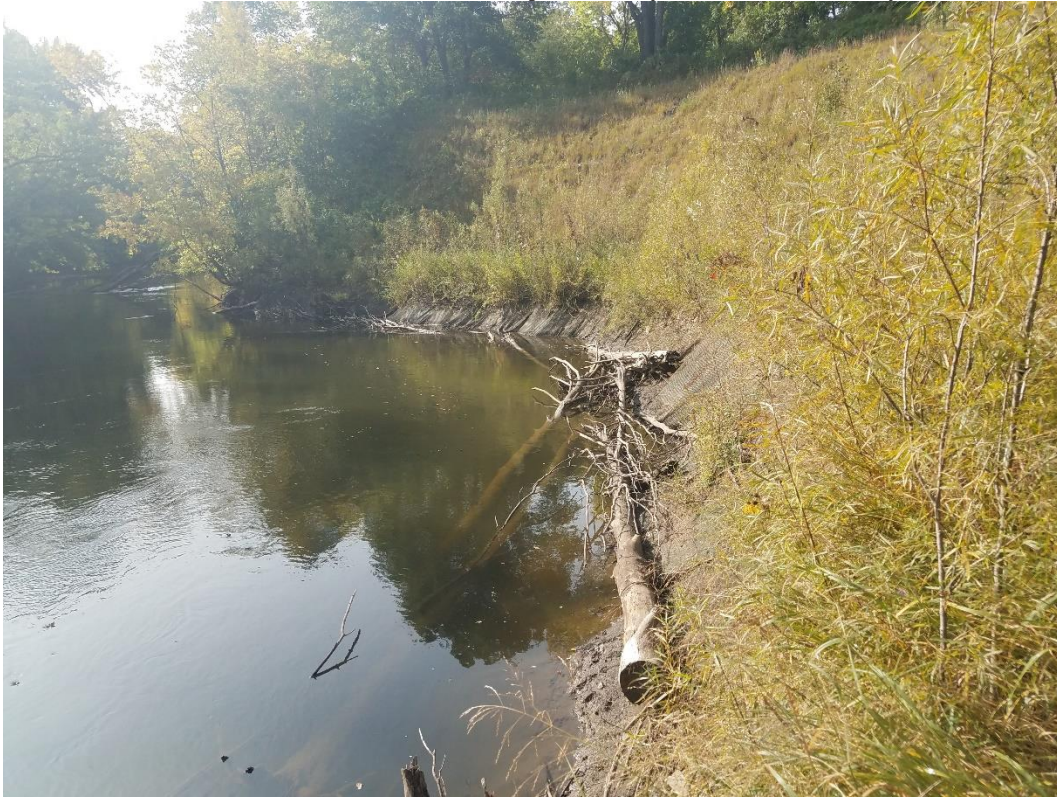
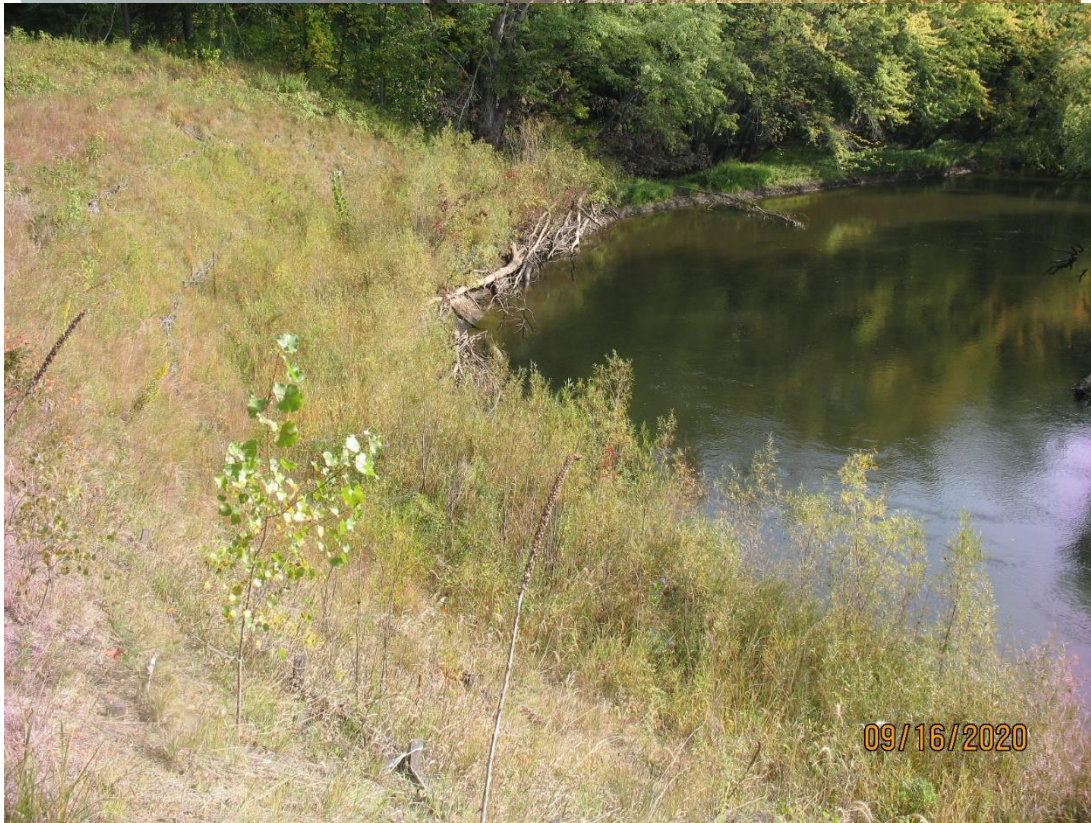
Site 4 – Princeton Elementary School (2014 Construction)

No significant maintenance issues were reported at the Princeton Elementary School Site.

- Apply fertilizer

- Monthly inspection of the site to document bank erosion and sloughing areas and determine if additional repair work is required.

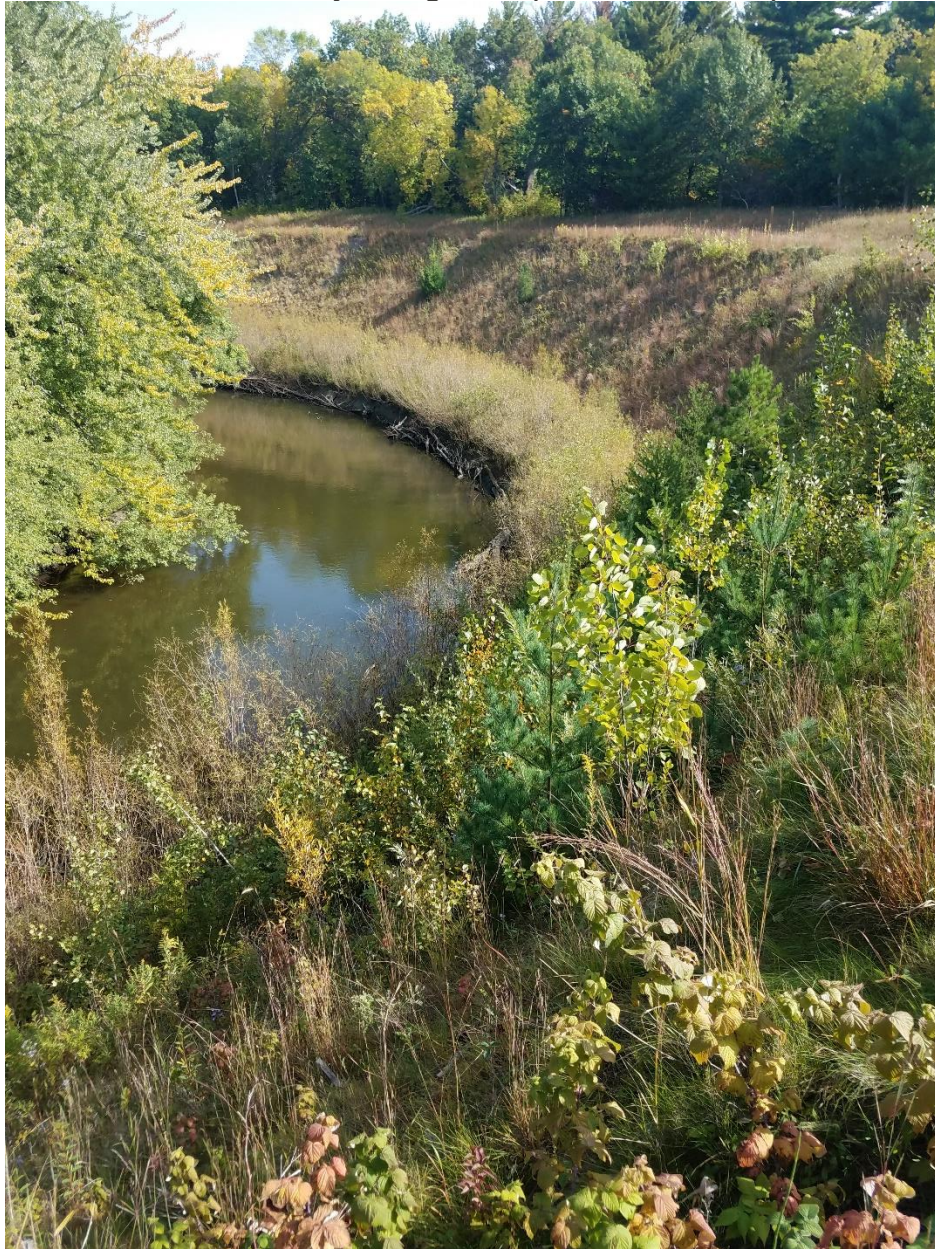
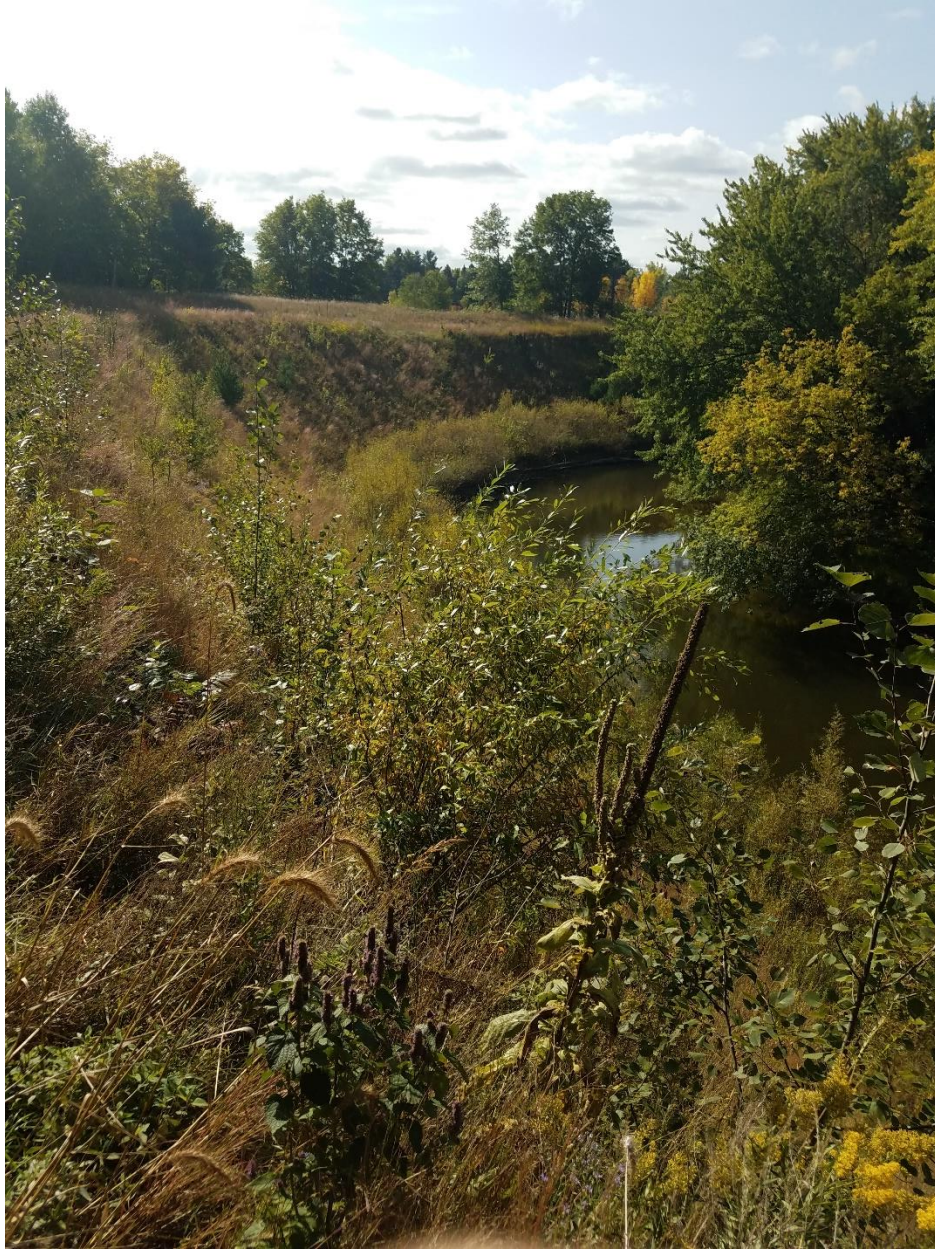
Site 5 – Abney Salvage Yard (2014 Construction)

- Some bare spots which need additional vegetation.

- Planted arborvitae and small pine trees
- Filled minor rills with wood chips to slow runoff erosion

- Continue to water the trees planted in 2019 and 2020 in order to encourage growth and establishment.
- Monthly inspection of the site to document washouts and determine if additional repair work is required.
